A PRACTICAL CONSERVATION GUIDE

MORECAMBE TOWNSCAPE HERITAGE INITIATIVE (THI) 2: A VIEW FOR ERIC

and MORECAMBE CONSERVATION AREA.

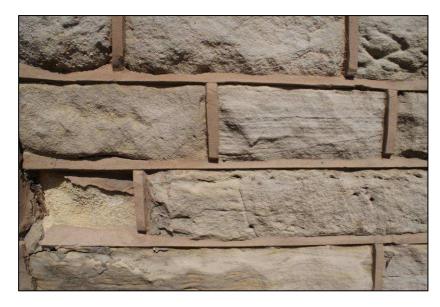
An example of the physical and visual damage caused by inappropriate mortar and pointing

This is in direct contrast to cement which is an impermeable material, thus trapping moisture, and accelerating decay. Moisture is unable to move through the joints forcing water into and through the stone itself, causing the masonry to sacrificially deteriorate. Further, with little or no flexibility, where the cement fractures or fails, moisture will be able to enter the walls.

On a visual level, however, repointing with cement also has a negative impact on the appearance of the building, this is often related to the colour and the method of application.

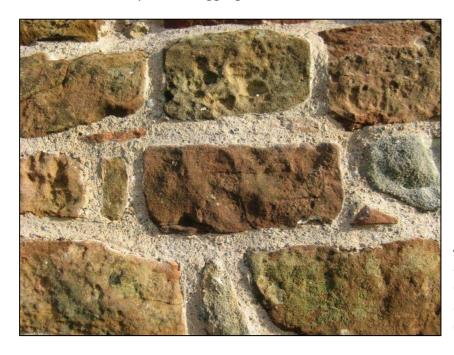
An example of how the pointing and mortar should look (colour, finish and recess)

In terms of the colour which should be achieved, the aim is for the mortar to blend in with the original stonework colour as closely as possible. The idea is not for each stone to be picked out, or to stand out. Given that a buff/yellow sandstone (mill stone grit) has been used in this area, a buff coloured mortar is required, and pink, brown or grey mortar should be avoided.

Uneroded stones should be flush pointed. Badly eroded stones should have the pointing slightly recessed so that the joints are not visually widened.

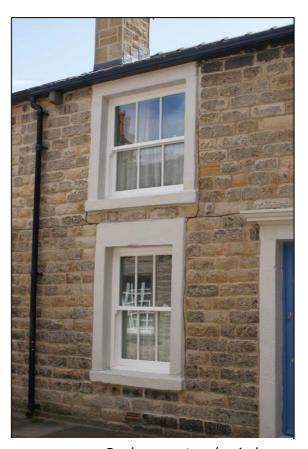
Replacement sash windows

The traditional detail in Morecambe tends to be one of minimal glazing bars, due to the date of the buildings' construction. Many have no glazing bars at all, though some just have one or two vertical bars, such as those in the photo.

Sash horns are also a common detail, due to the lack of glazing bars, and the consequently larger sheets of glass involved. The role of the sash horns was to provide strength to the vulnerable joints at each end of the meeting rail.

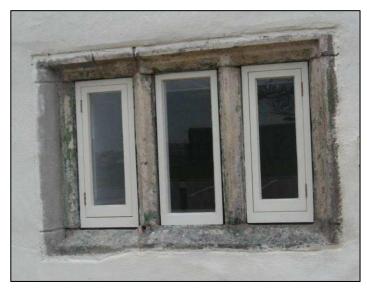
Where casement windows are considered the most appropriate fenestration treatment for a building, flush fitting casements are usually the most acceptable form. This is a traditional detail where the outer frame and the frame of the opening-light are flush in section, to the outside face of the window.

Flush fitting casement windows

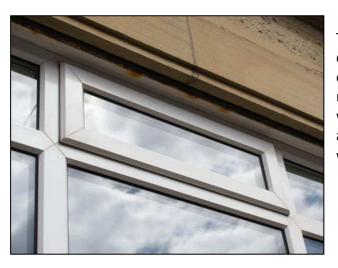
The more modern 'storm proofing' detail, where the opening light overlaps the fixed frame, can result in a much heavier looking window, more akin to the appearance of a uPVC casement window.

'Storm proofed' window

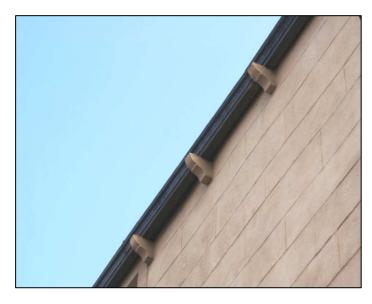
Cast iron ogee gutter supported on stone corbels

The use of cast iron 'ogee' section gutters is a common detail throughout much of Morecambe's C19 housing stock. These were usually supported on stone corbels, either plain or profiled. Many examples still survive.

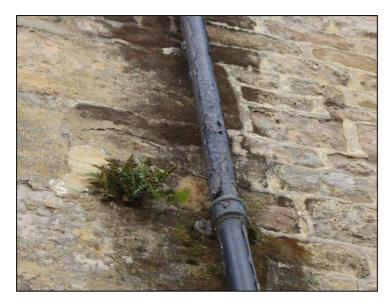
Staining, algal and vegetation growth caused by leaking and unmaintained rainwater goods

This can be caused by a lack of maintenance, including blockages and vegetation growth, and corrosion due to infrequent painting.

There may be indications that the rainwater goods are in need of repair. These can include staining of the walls behind, plant or algal growth on the stonework, eroded masonry and failure of render, for example.

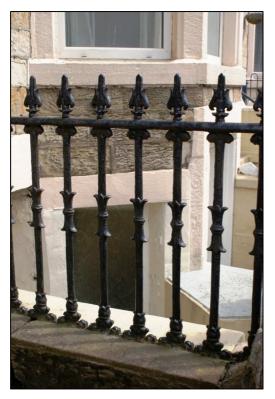
An important historic detail which should be replicated is the embedding of the individual vertical bars in the coping stone, as opposed to attaching a flat bar at intervals, which is a more modern detail.

Historic railings

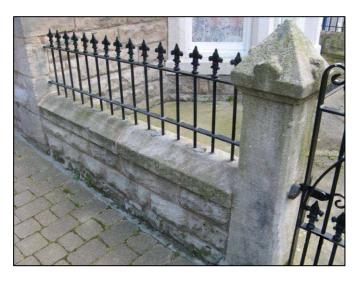
Reinstated railings
