Dolphinholme Conservation Area Appraisal

Adopted June 2016

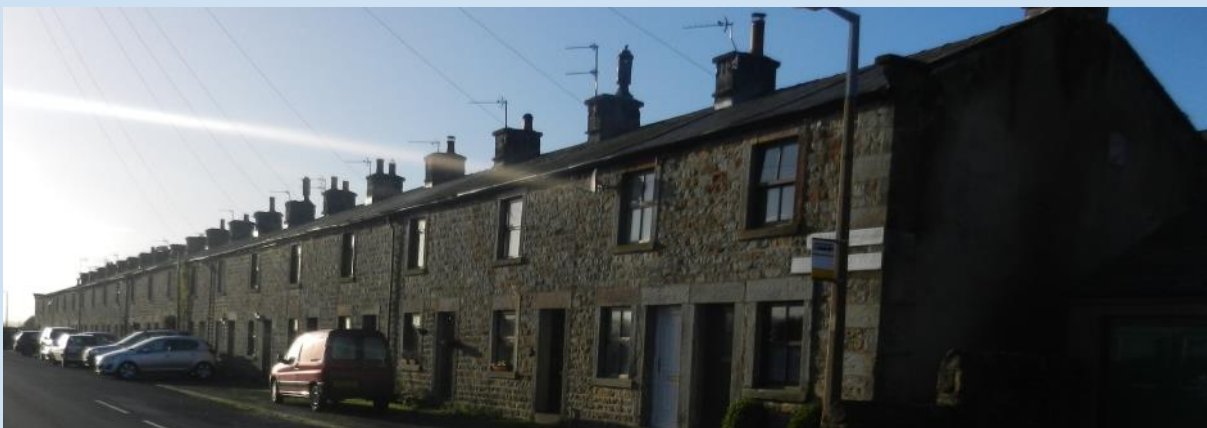
Fig. 16 1-18 Corless Cottages are two storey terraces constructed in coursed sandstone and grey slate roof. Each property has two windows, which originally would have been timber sliding sash, with stone surrounds. This terraced is located south east of 19-28 Corless Cottages, which are three storey grade II listed terraces.

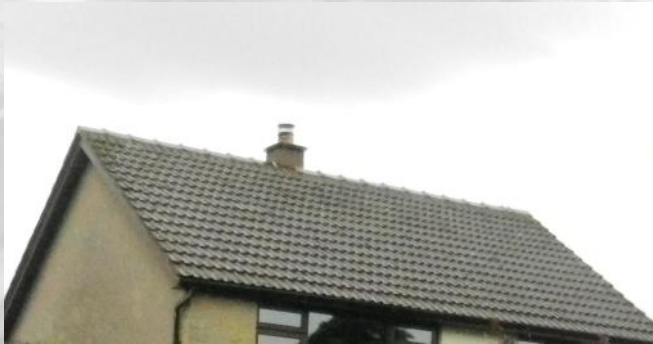
Although there are a variety of building types, there is a sense of unity between the historic and pre-20th century buildings as they are chiefly constructed in sandstone with a grey slate diminishing coursed roof. Originally, the windows of these buildings were timber sliding sash with stone surrounds and doors were timber panelled also with stone surrounds. However, some of these traditional details have been replaced with modern unsympathetic materials and styles in many unlisted historic buildings. This has negatively impacted the historic legibility of these buildings.

Fig. 26 Contemporary unnatural materials such as concrete pantiles for roofing.

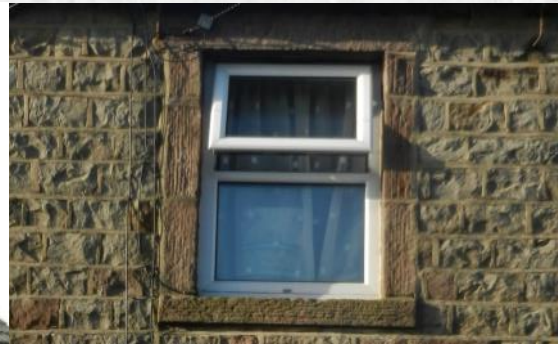
Fig. 27 Replacement of traditional timber sliding sash windows with PVCu alternatives.

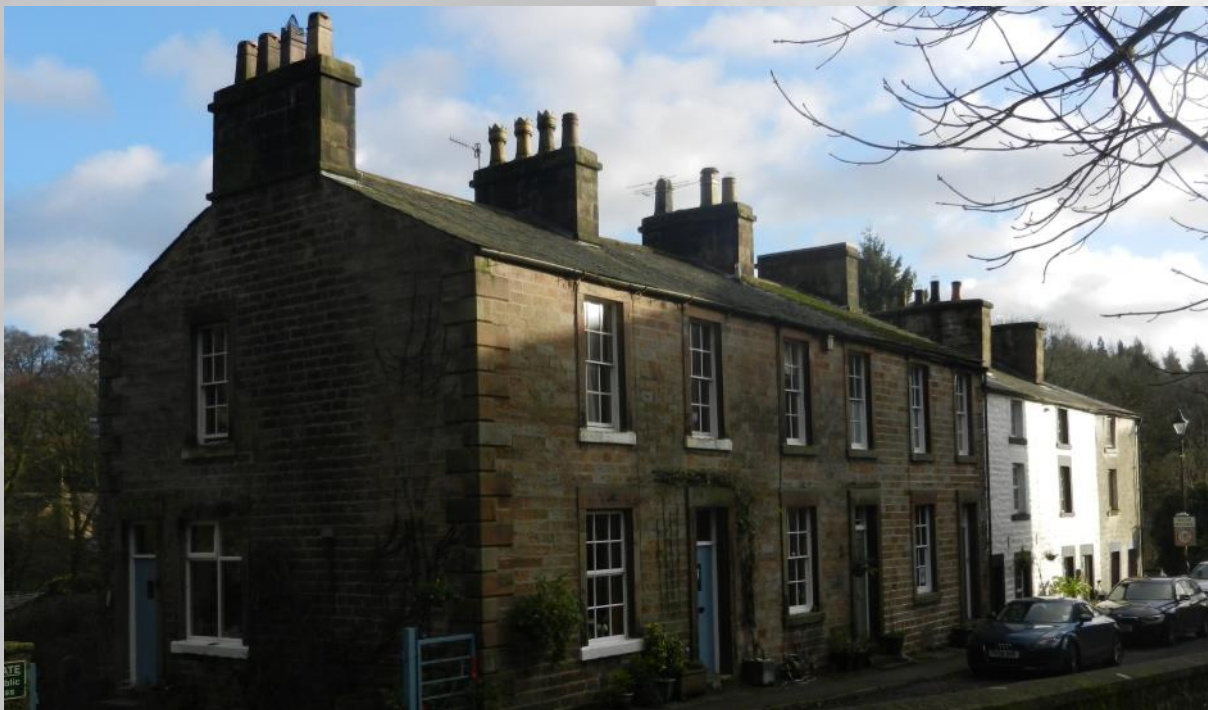
Fig. 28 Wagon Road terraced housing early 19th century - constructed in traditional materials such as sandstone, render and slate.

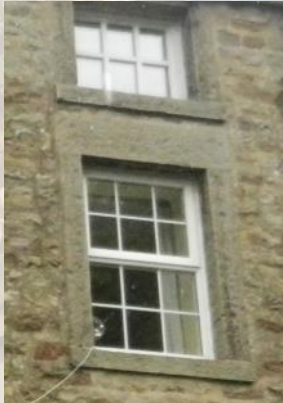
Fig. 34 Traditional sash windows have been replaced with modern upvc.

The assessment of the conservation area has identified it as in a relatively stable condition as no listed or unlisted buildings were identified 'at risk'. However, inappropriate alterations of architectural detailing, such as windows and doors, has negatively impacted the special historic and architectural interest of parts of Upper Dolphinholme's conservation area. To enhance the area's special interest, owners and developers should be made aware of conservation issues such as appropriate repair and alteration of historic timber sliding sash windows and panelled doors. Appropriate changes in architectural detailing will greatly improve the area's character.

In conclusion, there is an opportunity to improve the architectural quality of some of the unlisted buildings within Upper Dolphinholme's conservation area as these have been subject to modern inappropriate alterations. Continued unsympathetic developments will erode the architectural and historic interest of the area and people wishing to invest in the area should understand how the village has developed and what is the overriding historic and architectural interest of the area so as to best inform appropriate design.

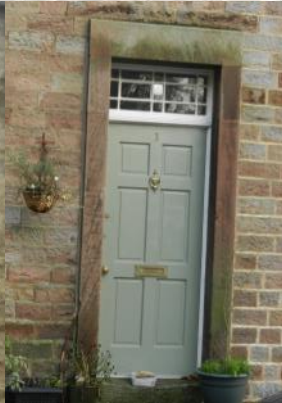
Fig. 35 Traditional timber panelled door has been retained.
