Arkholme

# Conservation Area Appraisal

Adopted January 2016

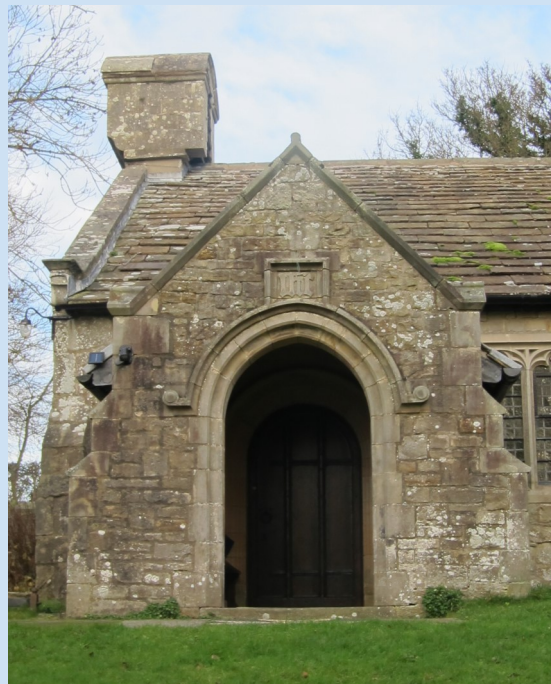
Fig. 4 St John Baptist church is grade II\*. The building has parts which date back to the 15th century. A lot of the church was restored by local architects Austin and Paley in the late 19th century.

The church of St John the Baptist is situated at the south easterly edge of the conservation area boundary. It is Grade II\* listed building and significantly contributes to the historic importance of the area. Much of the church was restored by local architects, Austin and Paley in the 19th century, but the church still retains some parts which date back to the 15th century. It also relates to the vernacular expression of the village's built environment through the use of random sandstone rubble walling and stone slate roofing.

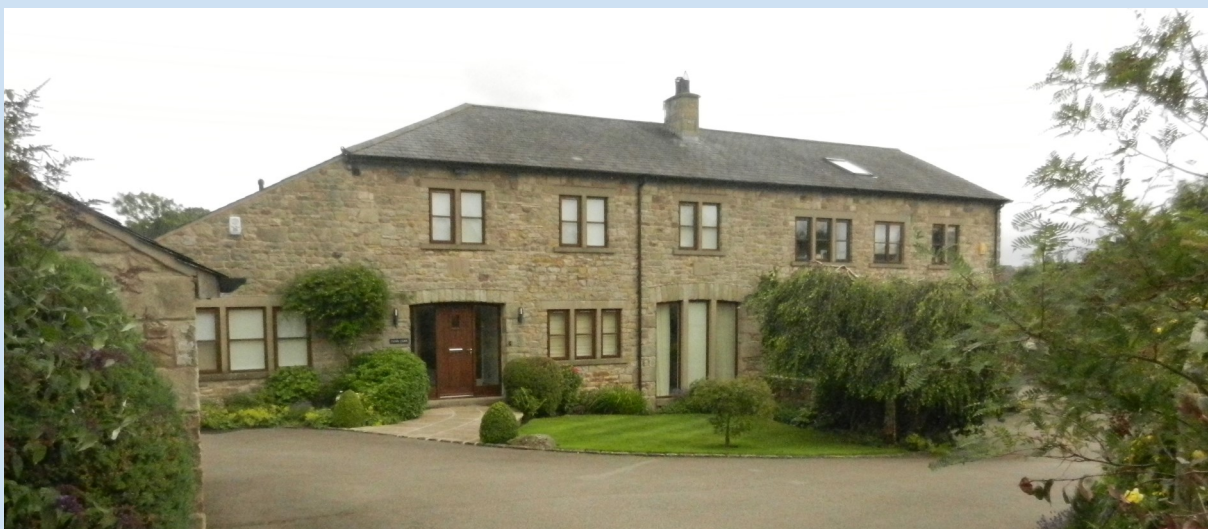
Fig. 5 Goss Lodge appears on the 1845 OS map as part of the land of Goss House. It has been converted to residential use, but like many other buildings in Arkholme it has retained its traditional barn door openings.

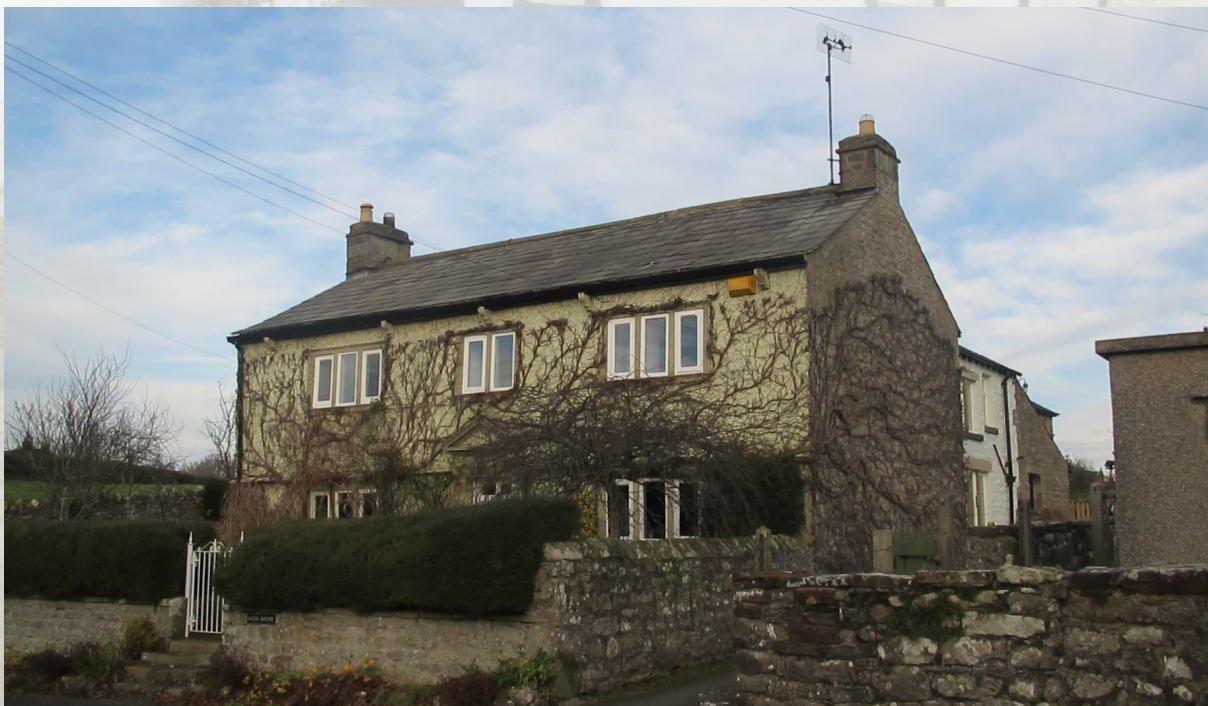
**Fig. 7** Goss House is a mid-18th century house, which has been traditionally rendered. The house shows influence of international styles of classical detailing above the doorway with a dentilled pediment. However, the prevalent vegetation growth on the building could threaten the integrity of the built structure as the roots can penetrate joints and cause displacement of the stone.

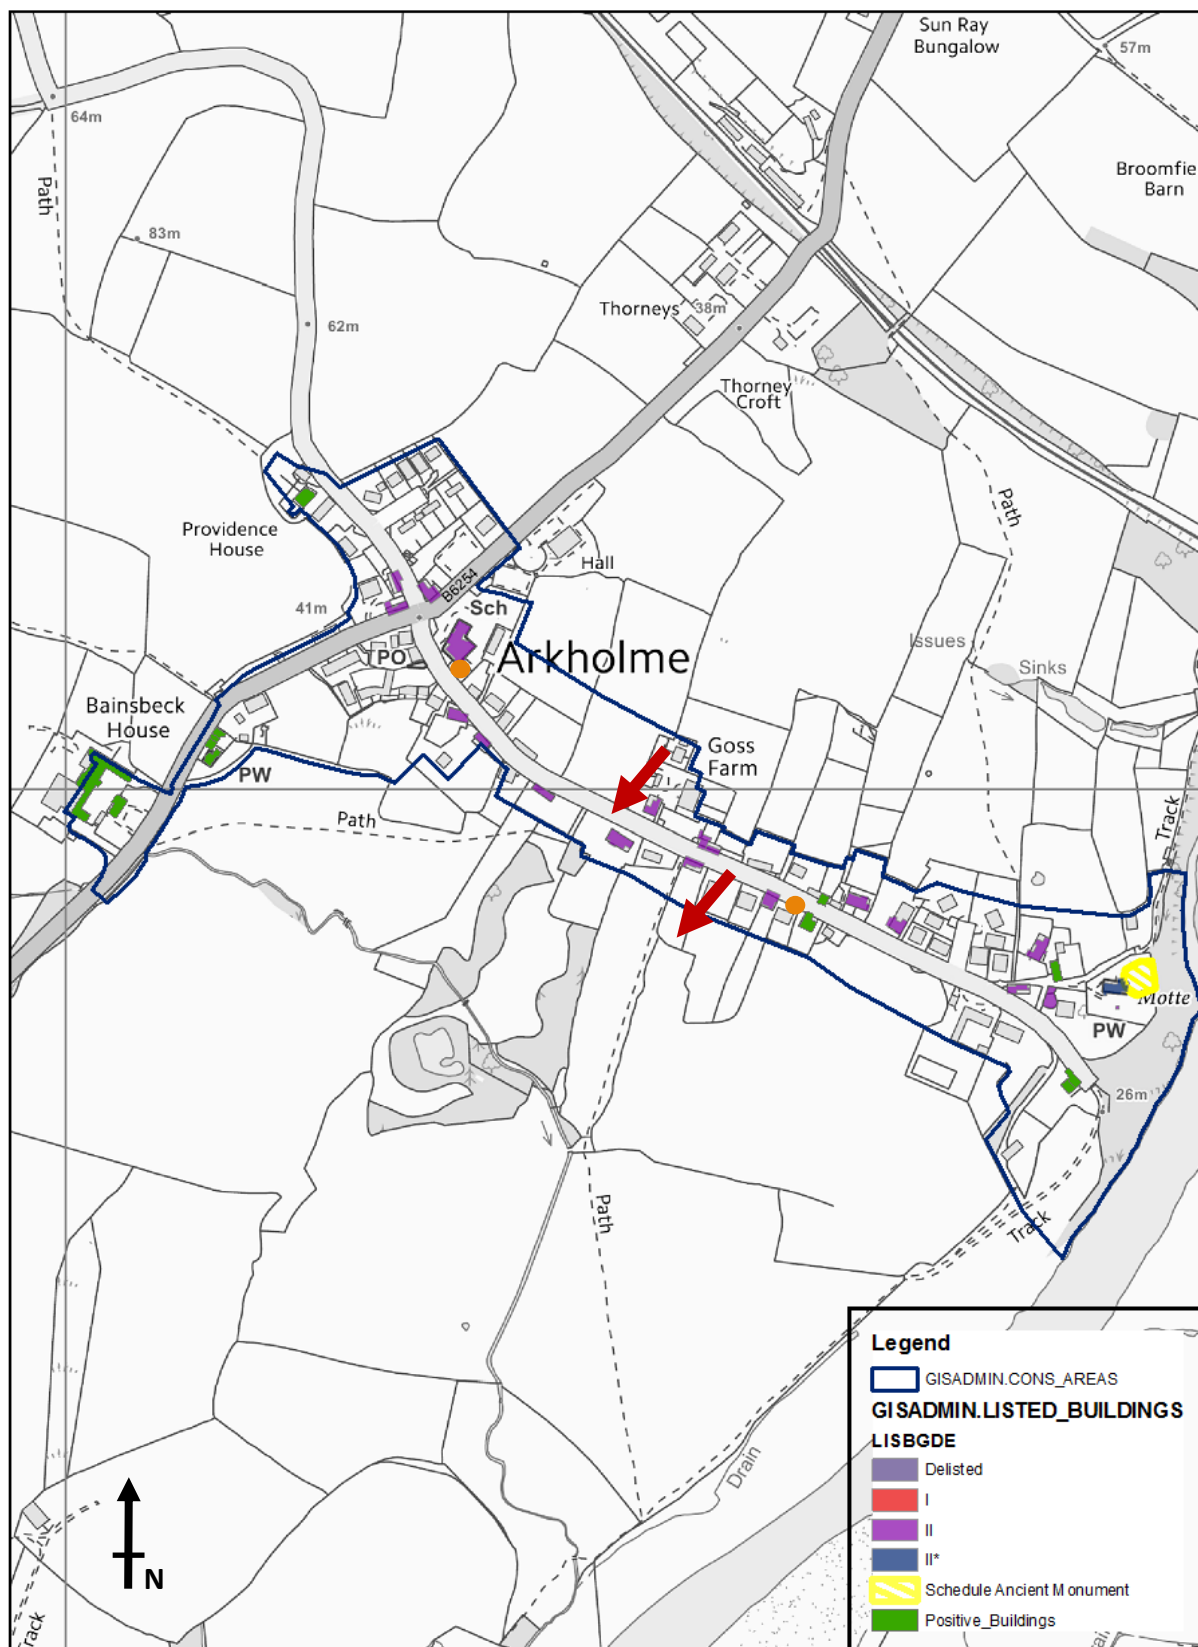
**Fig. 8** Map of Arkholme's Conservation Area Boundary, the map also highlights listed buildings and positive contributions within the boundary. Important viewpoints, as discussed in section 4.1, have been highlighted with red arrows. Areas with Tree Preservation Orders are identified with an orange circle and discussed in section 4.5.

As seen in Fig. 8, the conservation area covers the whole of the village and some open spaces that contribute to the important rural setting.

Important vantage points include the incline near Goss Farm and along Main Street looking west. These have been identified on a townscape analysis map in Fig. 8.

There are five Tree Preservation Orders within the conservation area, which can be identified in Fig. 8. Mature trees contribute to the setting of the conservation area and anyone proposing to cut down or carry out work to a tree within a Conservation Area is required to give the Local Planning Authority six weeks prior notice.

The following structures and buildings have been identified on Fig. 8 as significant unlisted buildings that make a positive contribution to the historic legibility of Arkholme's conservation area:

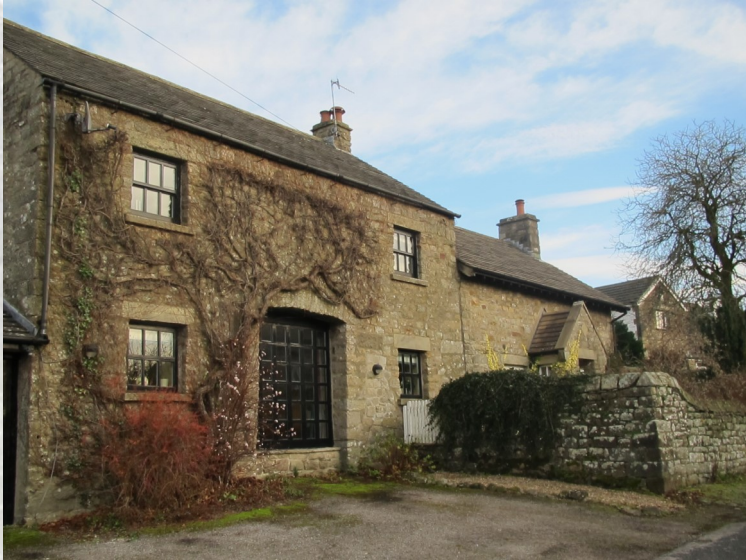
**Fig. 9** Architectural detailing associated with the previous agricultural use has been well maintained in Arkholme, as can be seen with the retention of the segmental arched barn door opening after the building was converted to residential use.

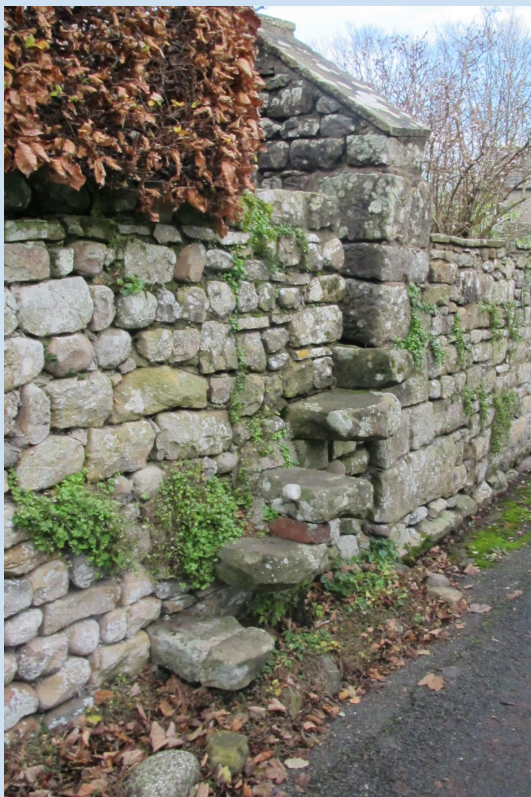
**Fig. 12** Traditional drystone boundary walls characterise the village of Arkholme, some with flat coping stones.

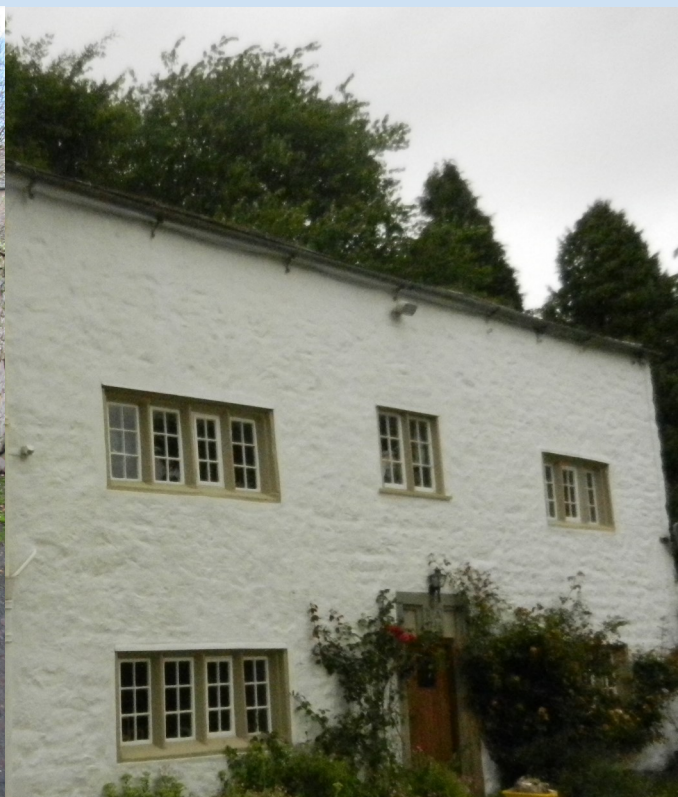
**Fig. 13** Luneside, previously known as Lune Cottage, is a traditionally rendered house with a datestone of 1714 above the door.

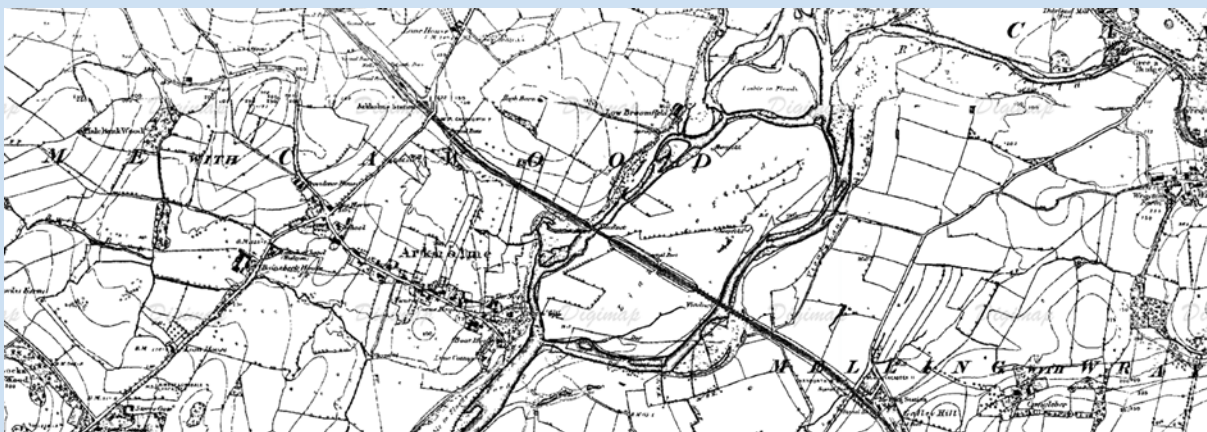
Fig. 16 OS map (1:10,000) of Arkholme in 1890, showing the linear settlement plan form and the development of the railway on the outskirts of the village.

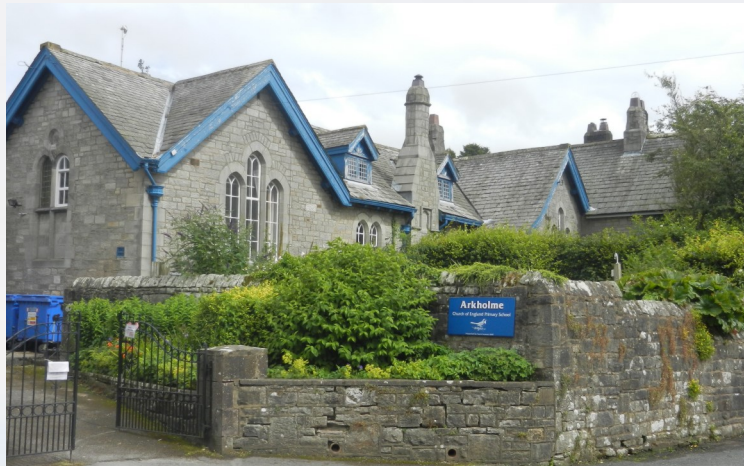
**Fig. 17** The school and schoolmaster's house were built in the mid-19th century, it demonstrates the end of the vernacular building tradition as architecture began to be influenced national revival styles, as seen with the pointed arch detailing of the windows.

GV II School and schoolmaster's house, 1867. Snecked sandstone rubble with slate roof. One storey with attic. At the right is a projecting gabled wing with a porch to its left under catslide roof of lightly shallower pitch. The wing has triple stepped chamfered lancet windows with glazing bars. The porch has a chamfered doorway with pointed arch. At the left of the facade, under a gable, are triple lancet windows-similar to those to the wing. To the right is a window of 2 similar lights. Above is a timber attic dormer, with a 2nd dormer further right above the porch. Between the dormers is a chimney projecting forwards from the wall, tapering to an octagonal cap. At eaves level is a plaque inscribed: 'Erected to the memory of the Rev. Robert Cort...MDCCCLXVII.' Projecting forwards at the right of the building is the house, of 2 storeys and one bay under a gable. The windows have chamfered mullions, of 3 lights on the ground floor and 2 lights above. The doorway is in the left-hand return wall, under an open timber porch. Chimney on ridge in line with doorway.

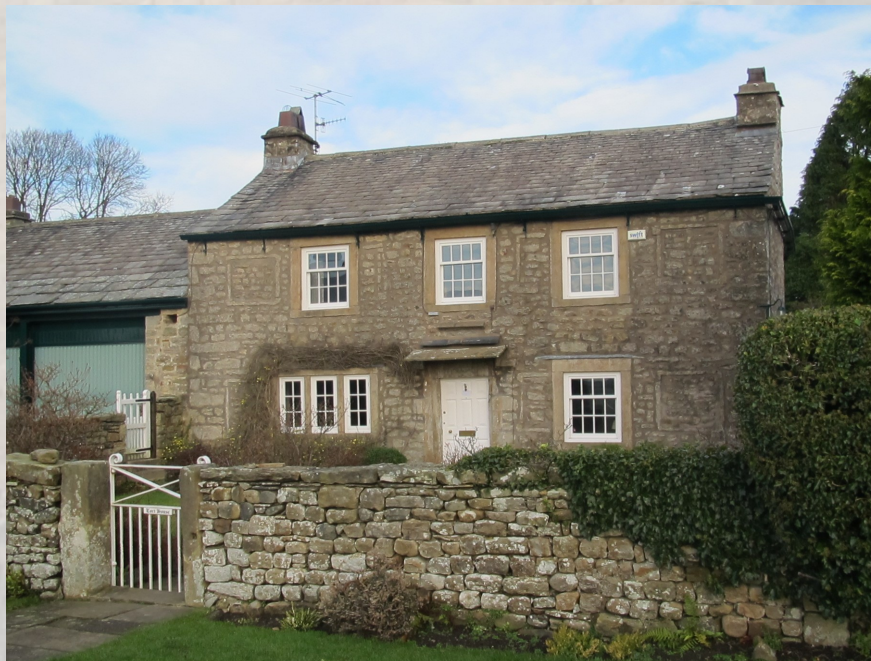
**Fig. 18** Cort House dates from 1700, it has been traditionally constructed in sandstone rubble with a slate roof.

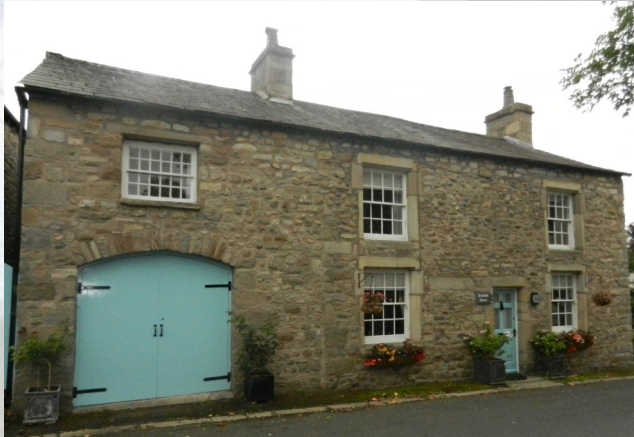
**Fig. 19** Brunt hill House was built as a farm building (on the left) and a dwelling (on the right) under the same roof.

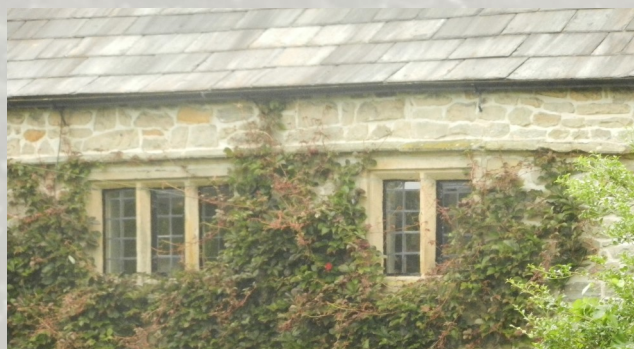
**Fig. 20** Mullioned windows have been well retained at Pool House and contribute to the historic legibility of the building.

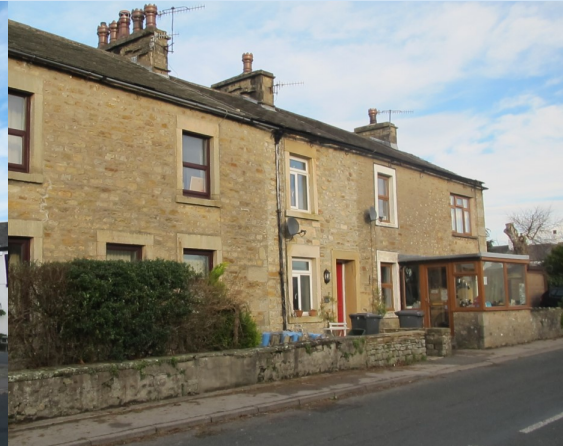
**Fig. 23** Use of non-traditional materials, such as upvc, for windows and doors negatively impacts the character of Arkholme's conservation area.

Architectural detailing, which crucially contributes to the historic character of Arkholme, has generally been well-retained. A very small proportion of unlisted buildings within the conservation area have replaced traditional windows and doors for modern unsympathetic alternatives, such as PVCu.

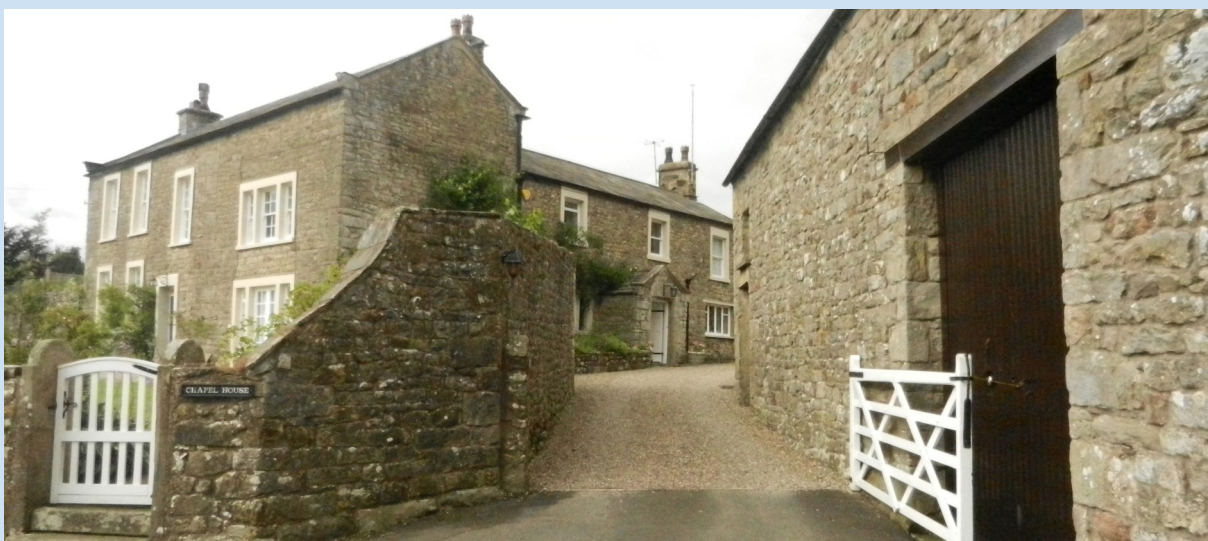
**Fig. 24** Church House and The Loft, previously known as 'The Nook' on 1845 OS map, constructed in rubble sandstone.

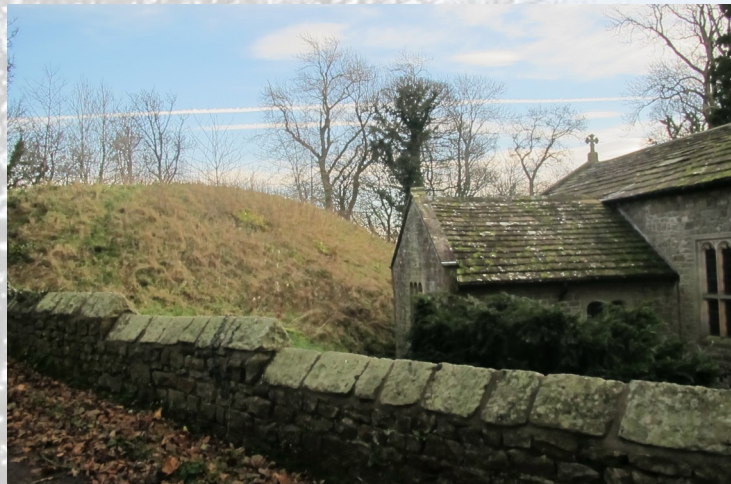
**Fig. 25** Chapel Hill motte is situated within the grounds of St John Baptist church.

Within the conservation area there is a scheduled monument of Chapel Hill motte, which was a medieval fortification introduced into Britain by the Normans after the conquest in the 11th century. This provides evidence that the village was occupied during this period and therefore has some archaeological potential, particularly to the east of the village, surrounding the Motte castle.

The monument at Arkholme comprises a truncated cone, the remnants of a medieval motte castle, situated on a commanding position dominating a slight bend in the River Lune overlooking an old river crossing. The motte lies in Arkholme churchyard immediately NE of the church, the vestry of which overlies the monument slightly on its SW. The bailey, which was originally attached to the motte, is now very indistinct as it has been considerably disturbed by burials and activities both within and beyond the churchyard. Because of the damaged state of this bailey it is not included in this Scheduling. The churchyard wall runs around the motte on the NW, N and E sides and acts as a retaining wall. This wall is excluded from the scheduling as is the corner of the vestry where it overlies the monument. The ground beneath the churchyard wall and the corner of the vestry, however, is included.

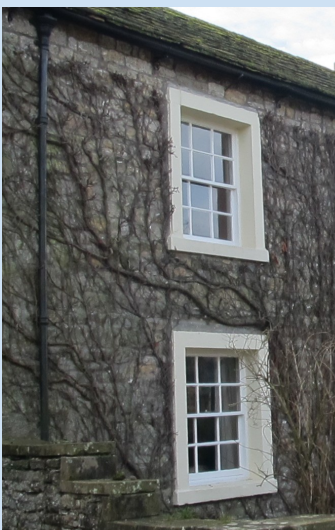
**Fig. 30** Caulking House retains the traditional 6-over-6 sash window fenestration.

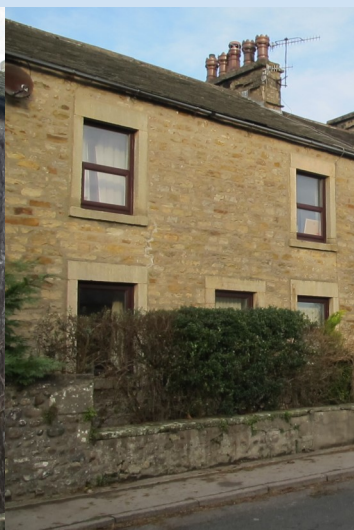
**Fig. 31** Some traditional sliding sash windows have been replaced with unsympathetic modern mock-sash casement opening windows.
