## 1.0 INTRODUCTION

Lancaster City Council  
**Halton Conservation Area**  
Townscape Appraisal Map  
Not to scale

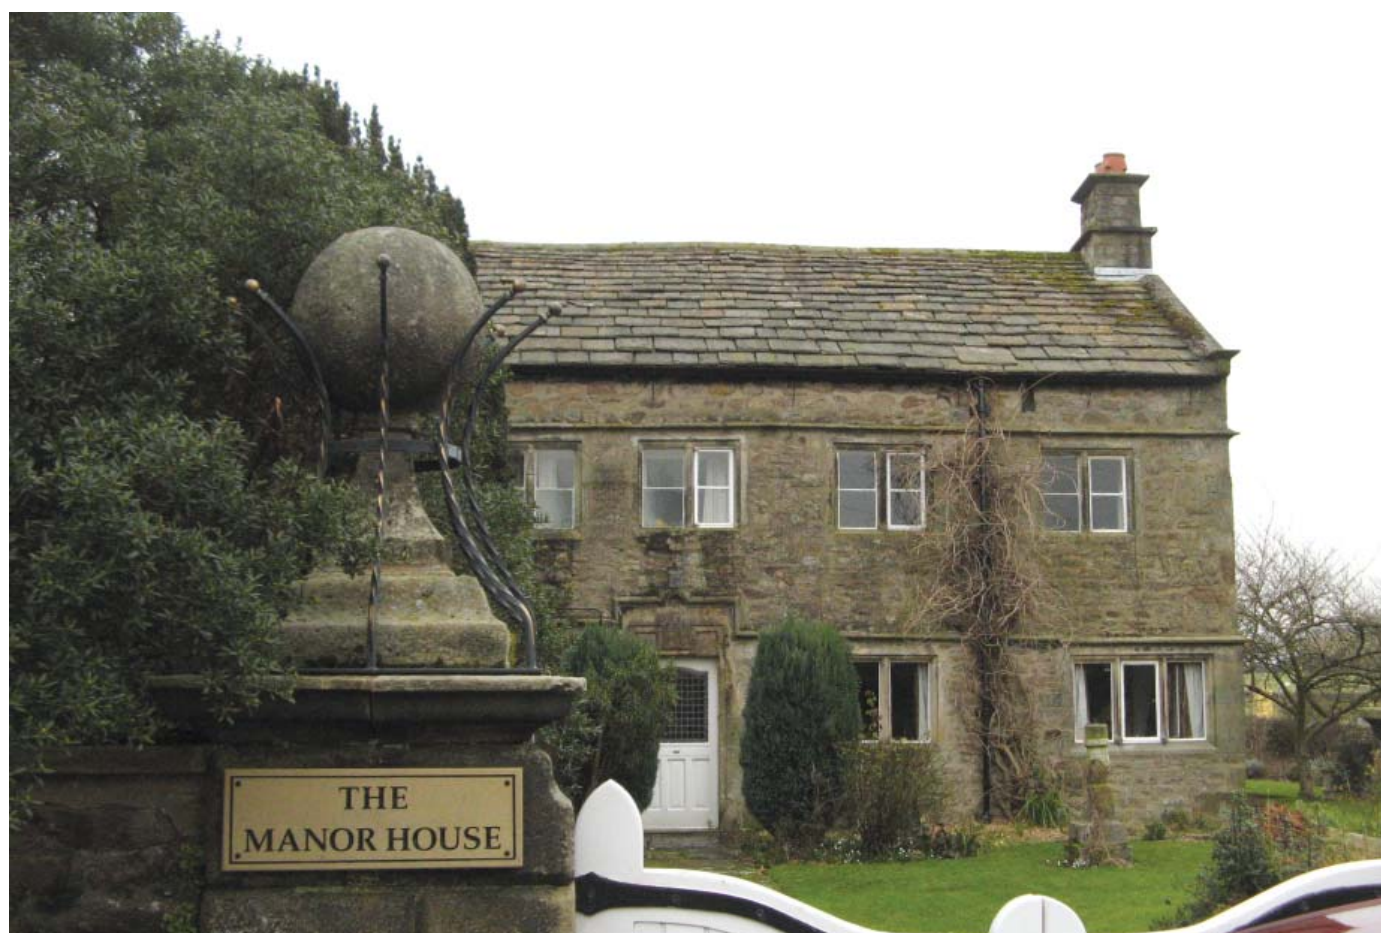
**The Manor House, listed building**

- 3.7 The 17th century was evidently not without prosperity. Townend Farmhouse (1672), Field Cottage (1679) and the Manor House (1695) are typical of substantial properties built during the period.

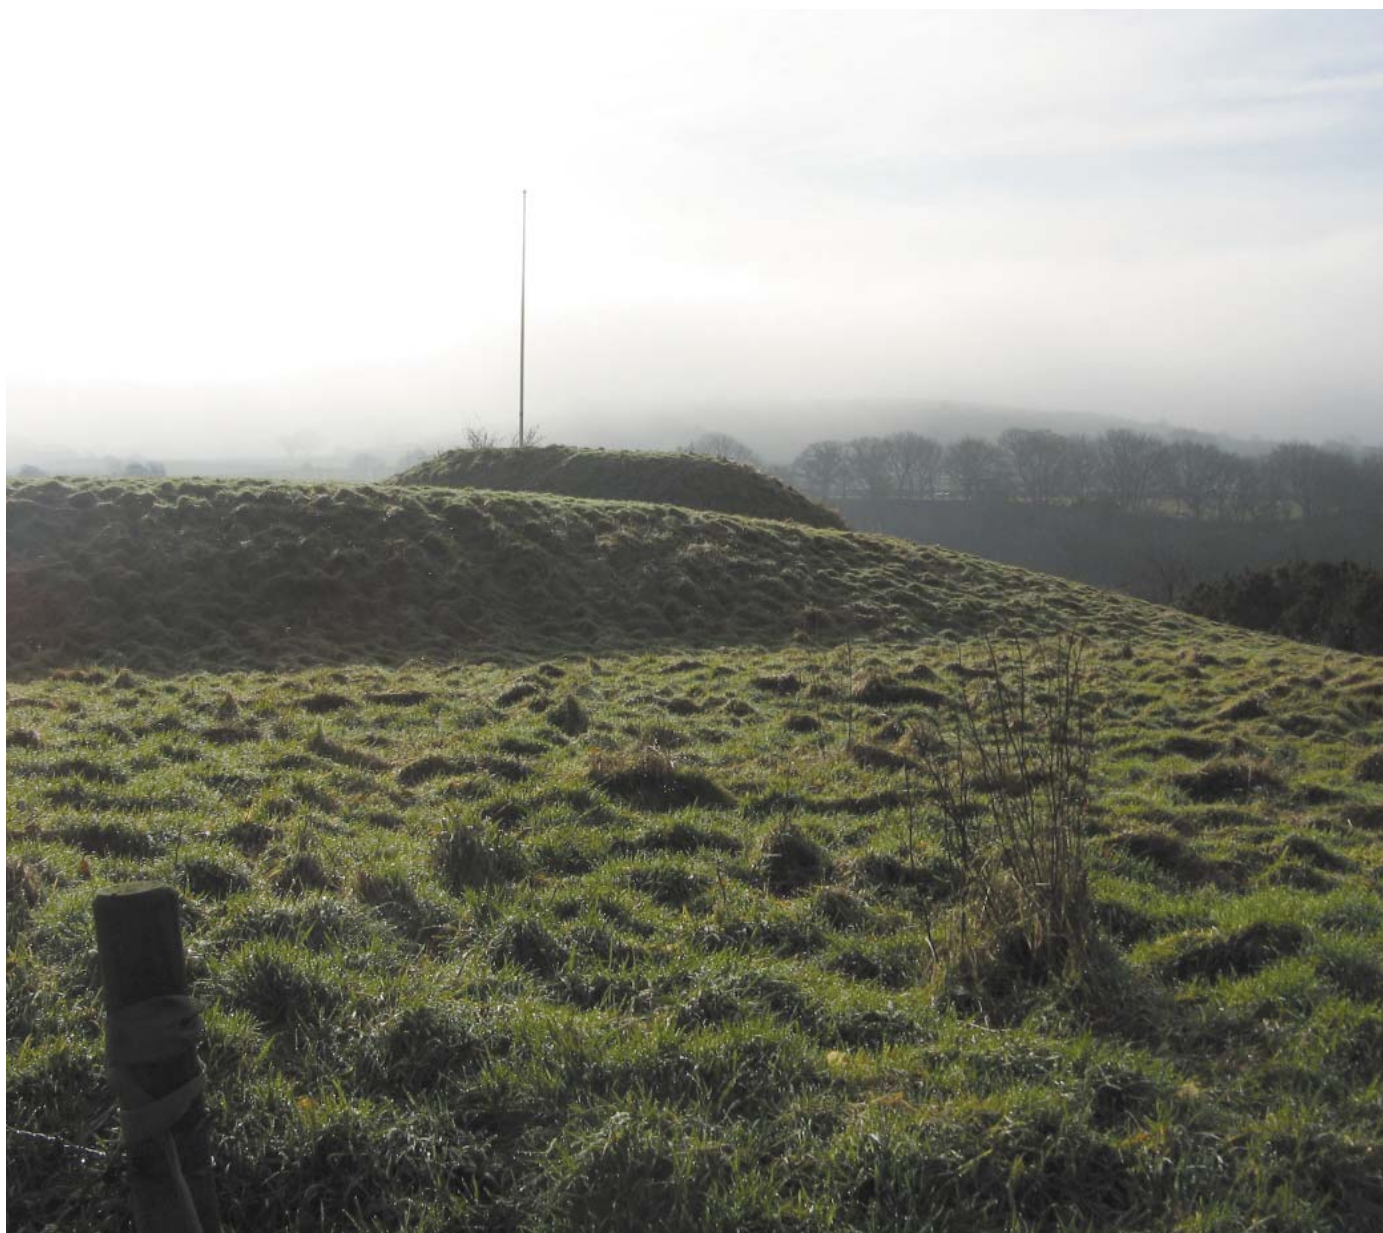
Earthworks of the 11th century castle

- 3.2 The evidence of this importance survives in the earthworks of the 11th century castle, which retains its motte and bailey form at the centre of the village. There is also a Saxon cross, dating from the 11th century, which stands in the churchyard where it was re-erected in 1891.

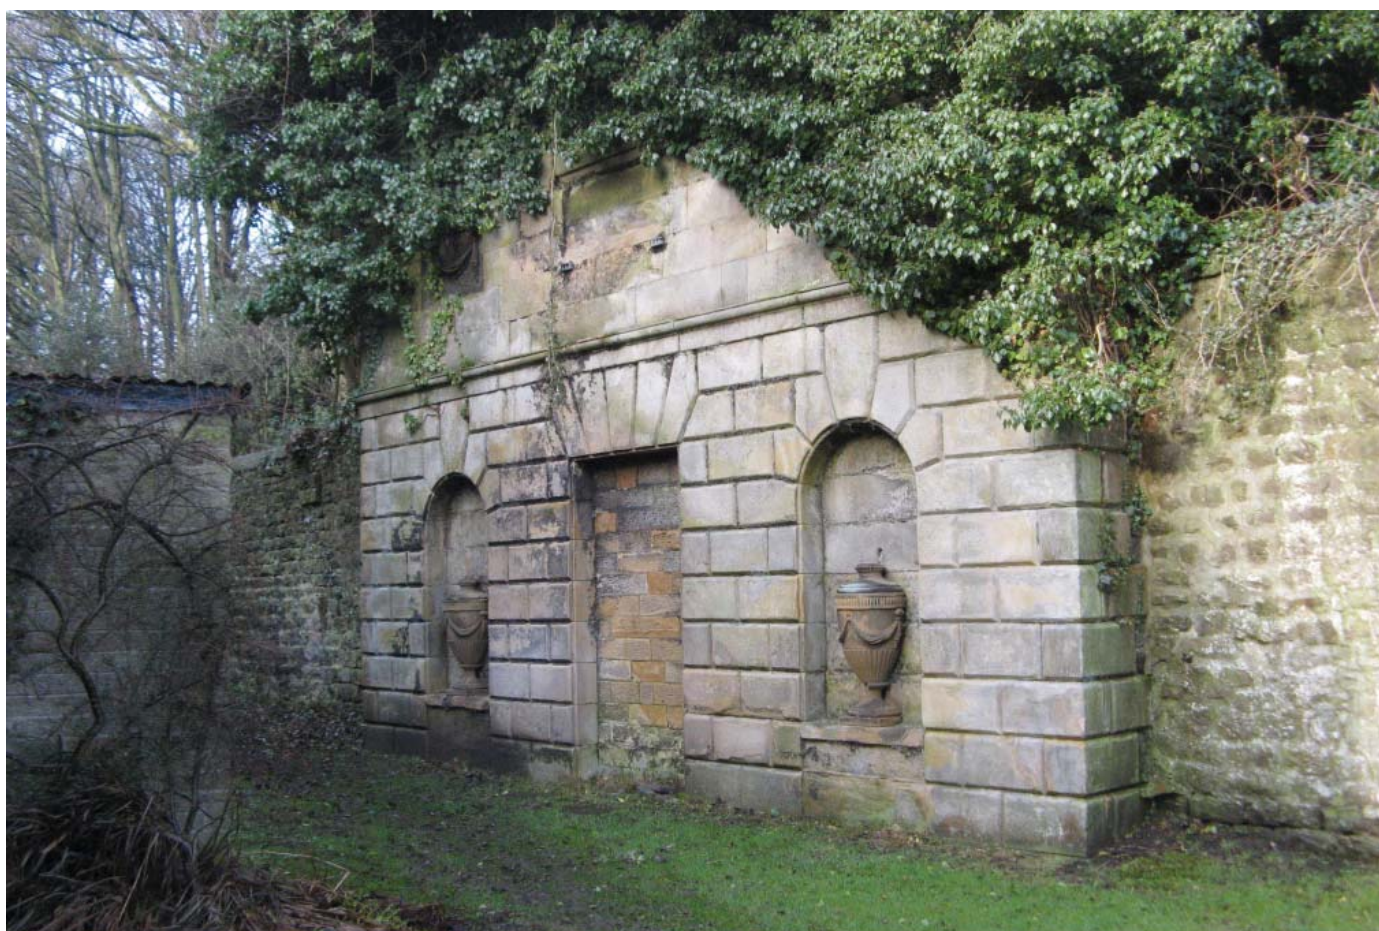
**Bradshaw mausoleum**

- 3.8 In 1748, the manor was acquired by William Bradshaw and it remained in the family for almost a century. The substantial Bradshaw mausoleum was built on the north side of the church in 1775, although the church was probably smaller then.

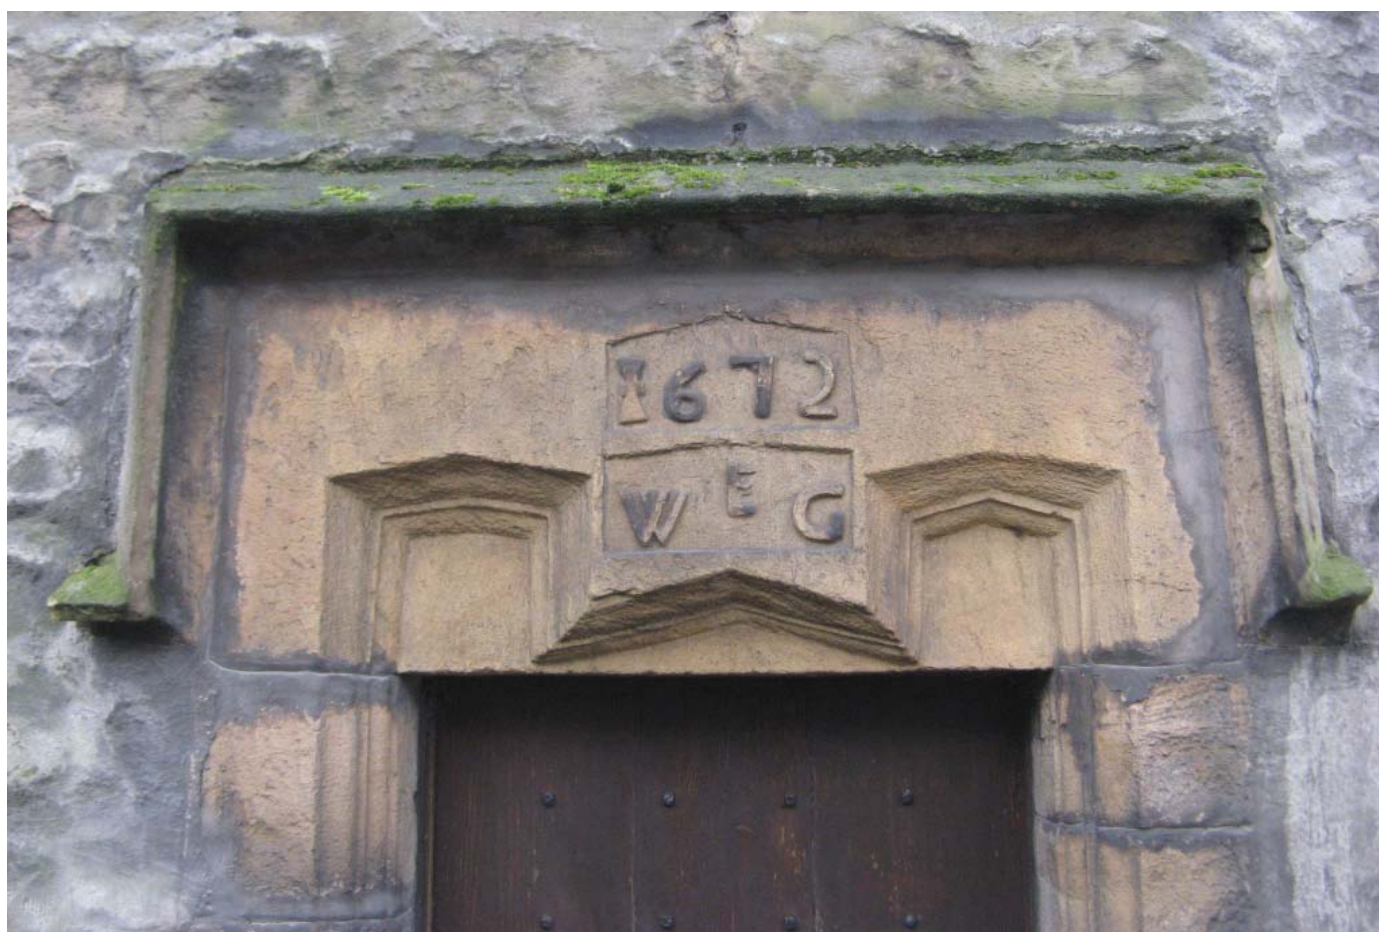
Ornate datestone

- 5.3 Buildings dating from the 17th and 18th centuries were built in the local vernacular tradition i.e. by local people using readily available materials and constructed with locally known practices of stone building and roofing. These buildings do not conform to a uniform architectural style, although features, such as mullioned windows with drip mouldings, gables with kneelers and copings, and ornate datestones, are common.

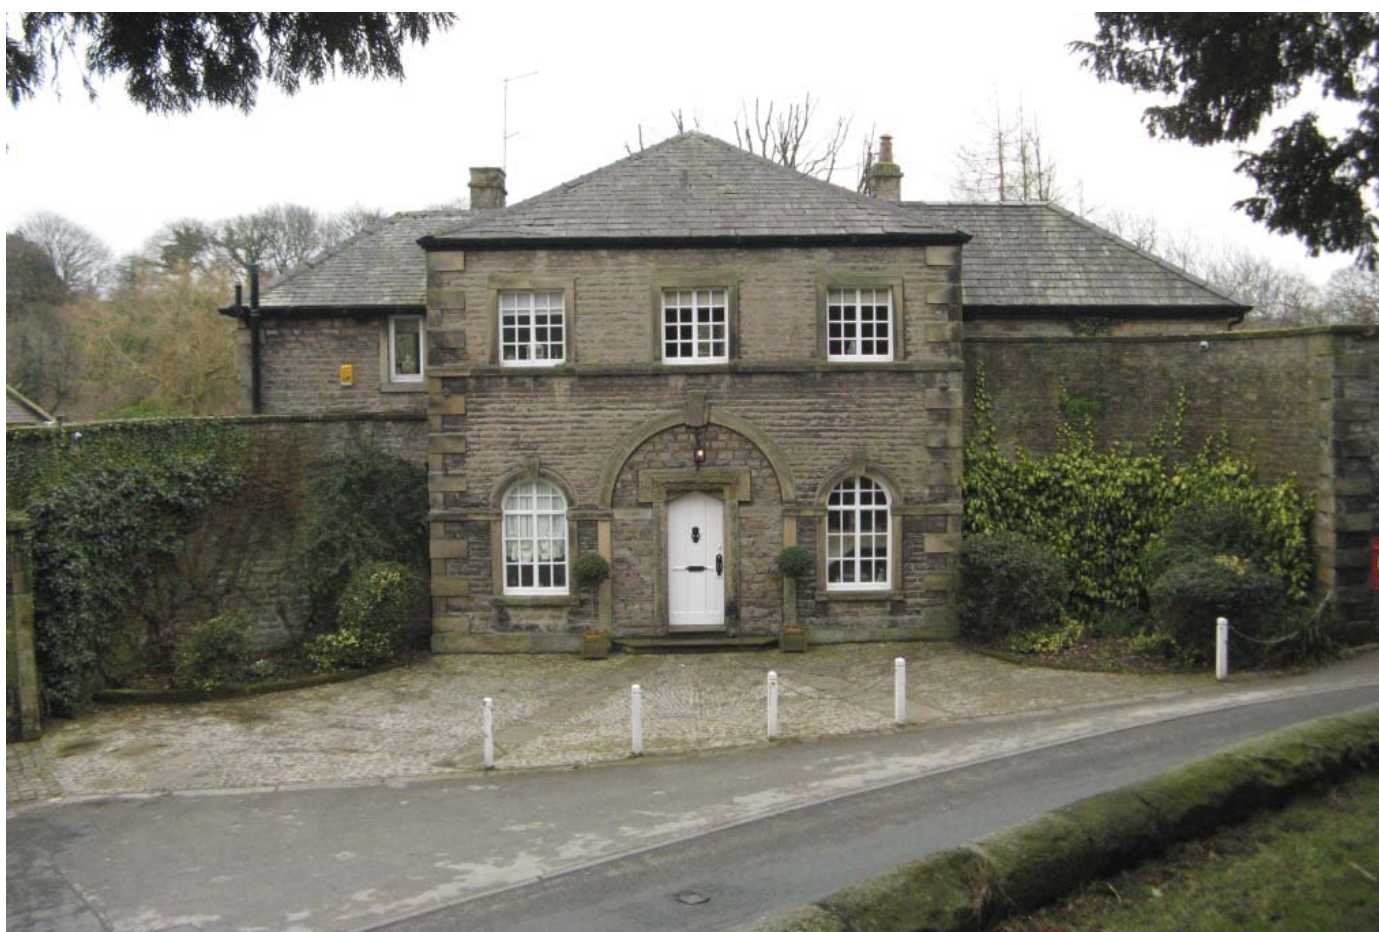
Clock House

- 5.4 From the mid-18th century onwards, a degree of formality and classical detailing enters the village. Typical of this are the Clock House, the gatepiers to the former Halton Hall and the Bradshaw Mausoleum. The stone tradition continued in the 19th century with houses that have symmetrical frontages with doors in the middle bay. These were the homes of the new businessmen. The Victorians also revived historical styles, for instance with the return to mullioned windows at St Wilfrid's Hall and, indeed, the 14th century styling of the rebuilt church.

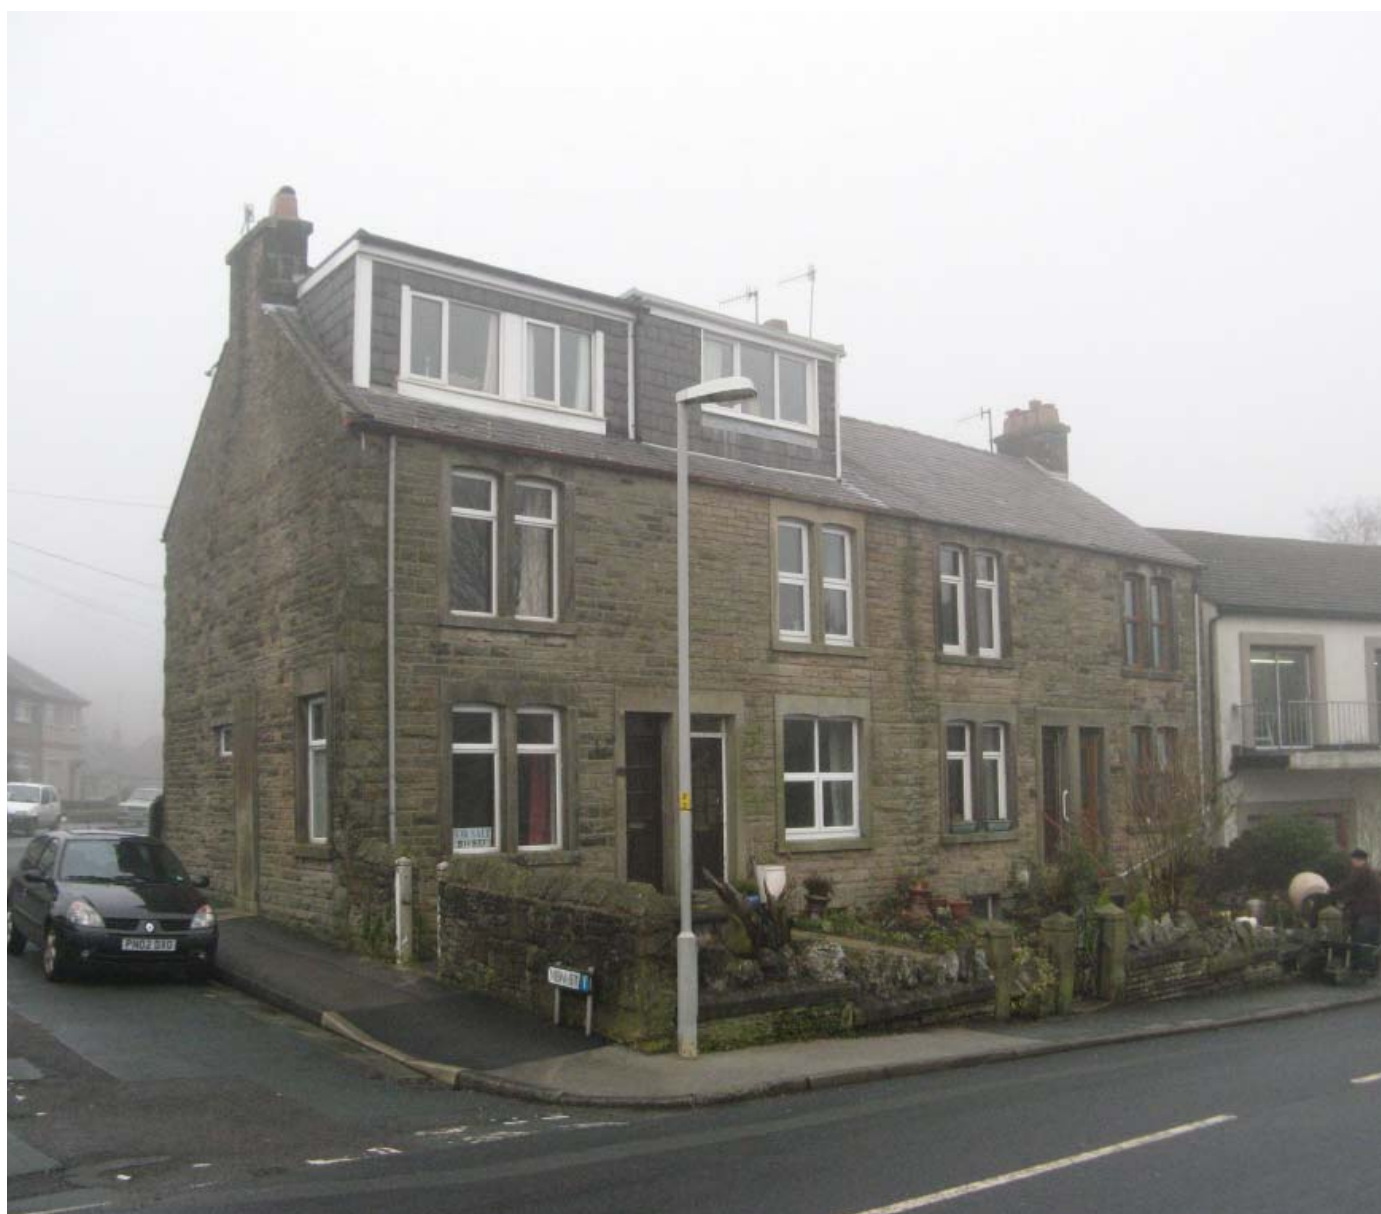
Modern alterations

- 6.2 In some cases, door and window openings have been altered, for example to create large wide windows in place of taller narrow ones. There are also instances where buildings have been extended in a manner which does not reflect the traditional design of the area's buildings, or that uses non-traditional construction materials. All of these have the effect of detracting from the original character of the host buildings.

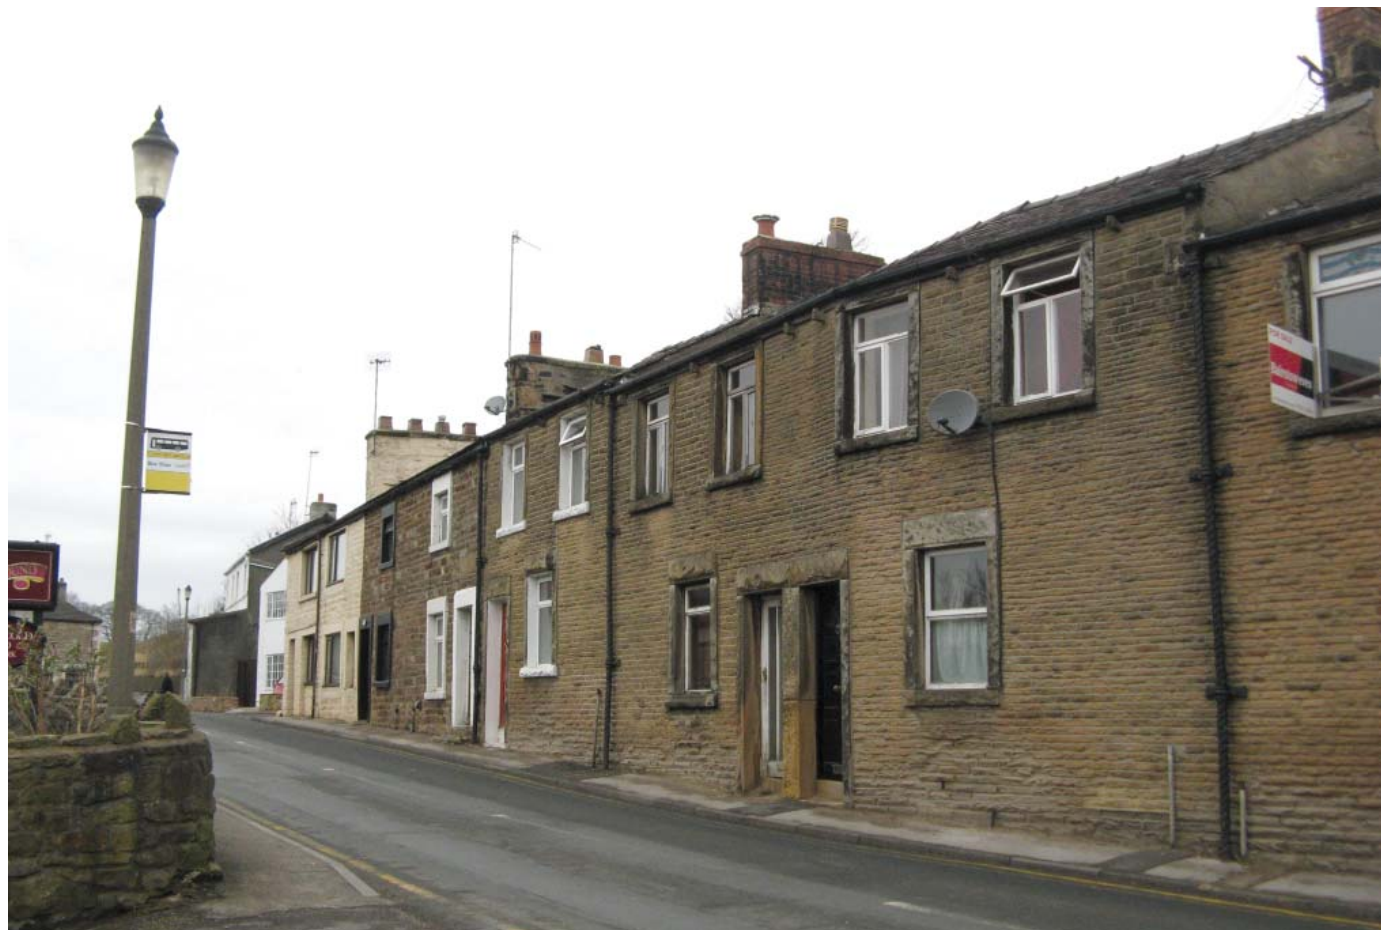
Satellite dishes

- 6.3 There are a number of instances where accretions such as satellite dishes and alarm boxes have been made on the elevations or chimney stacks of the historic buildings or where drainage pipes have been inserted in prominent positions, or rooflights inserted into the principal roofslope.
