# WARTON

## CONSERVATION AREA APPRAISAL

DECEMBER 2009

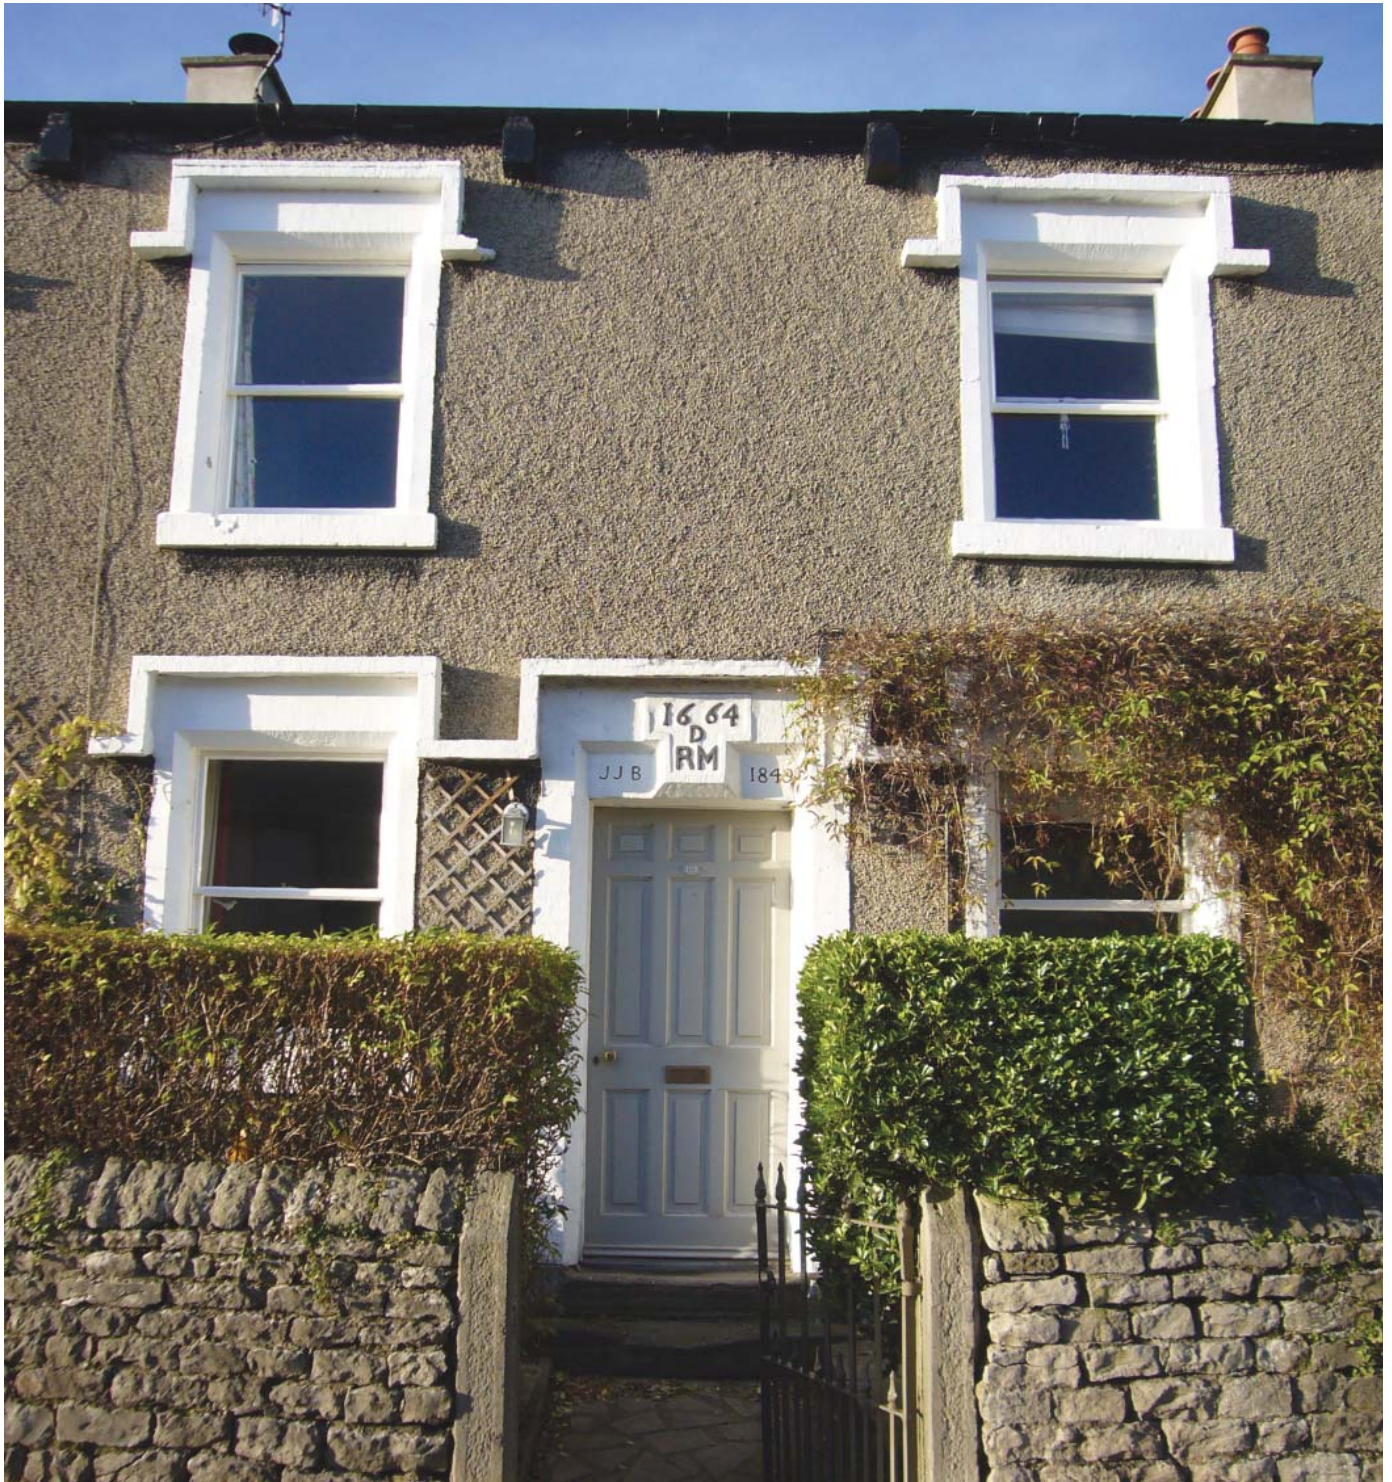
105 Main Street: a listed building dating from the mid 17th century
