This appraisal has been prepared on behalf of Lancaster City Council by:

## 1.0 INTRODUCTION

Warton

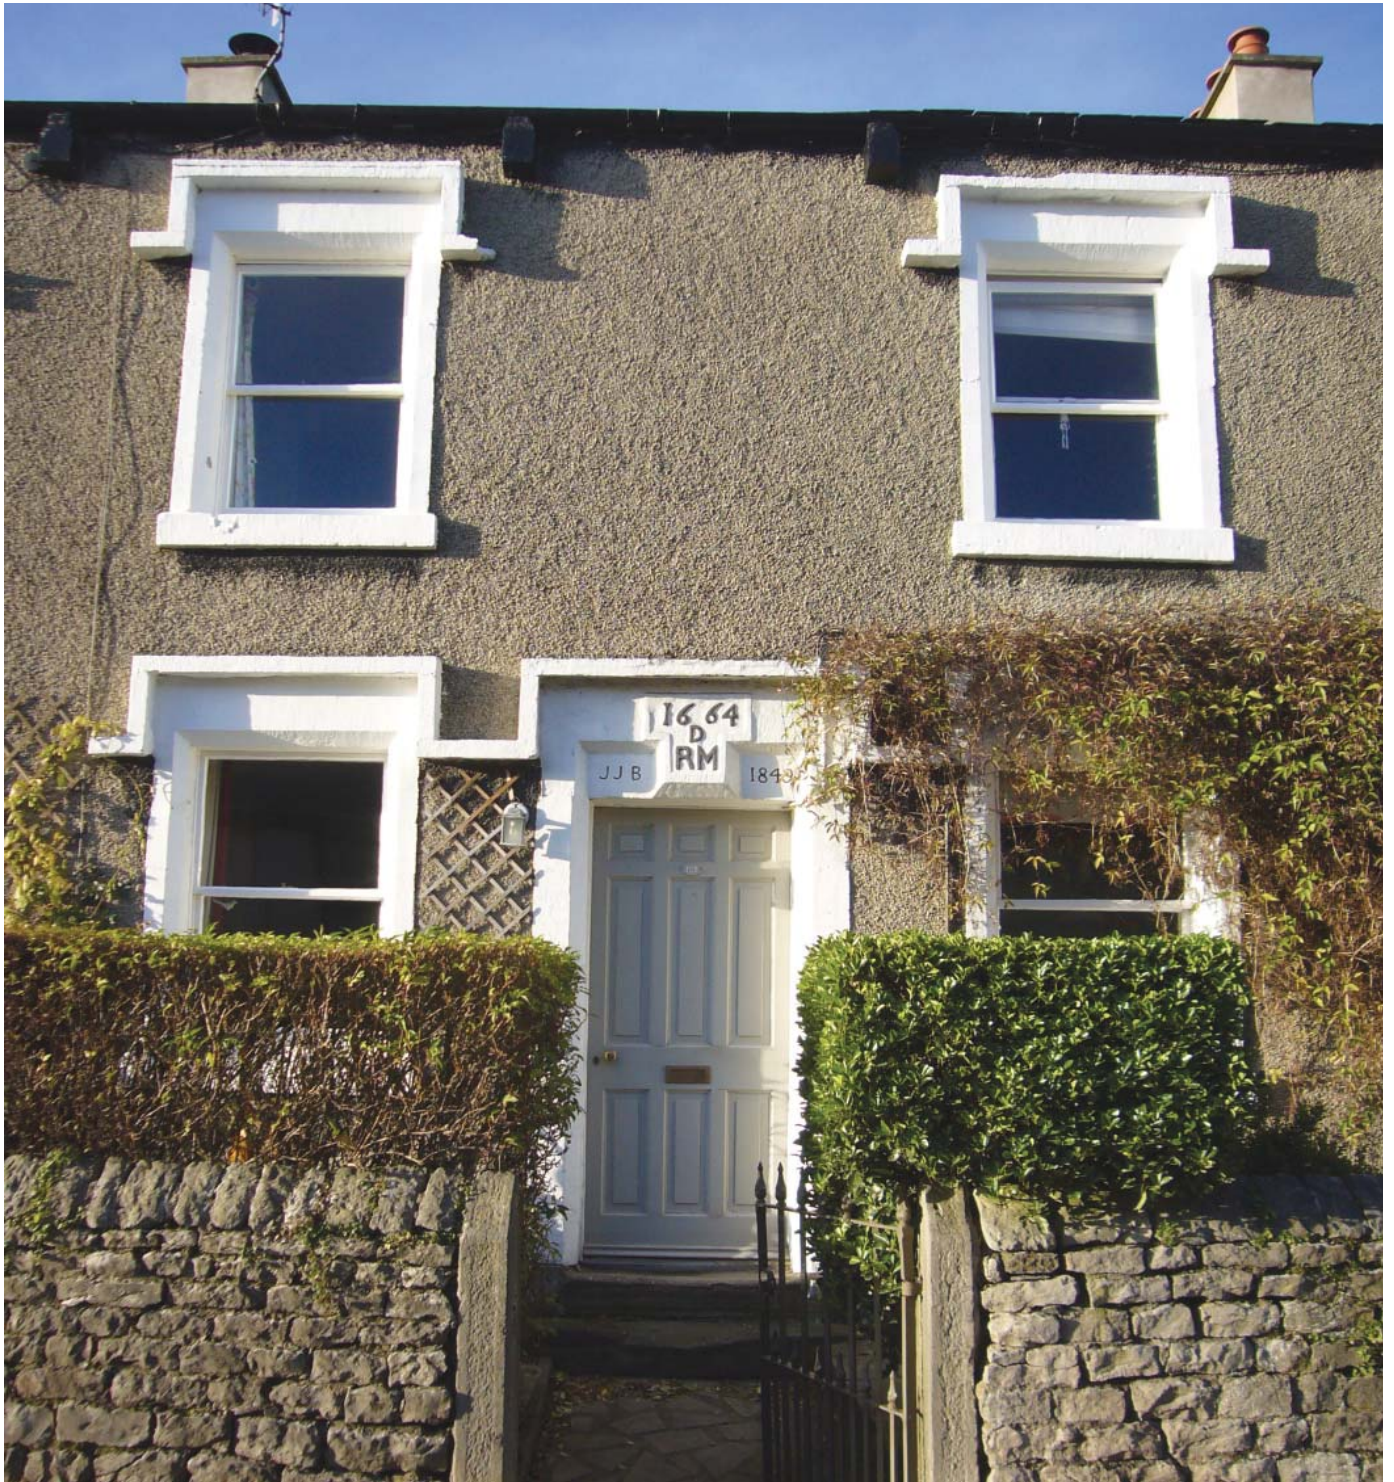
105 Main Street: a listed building dating from the mid 17th century

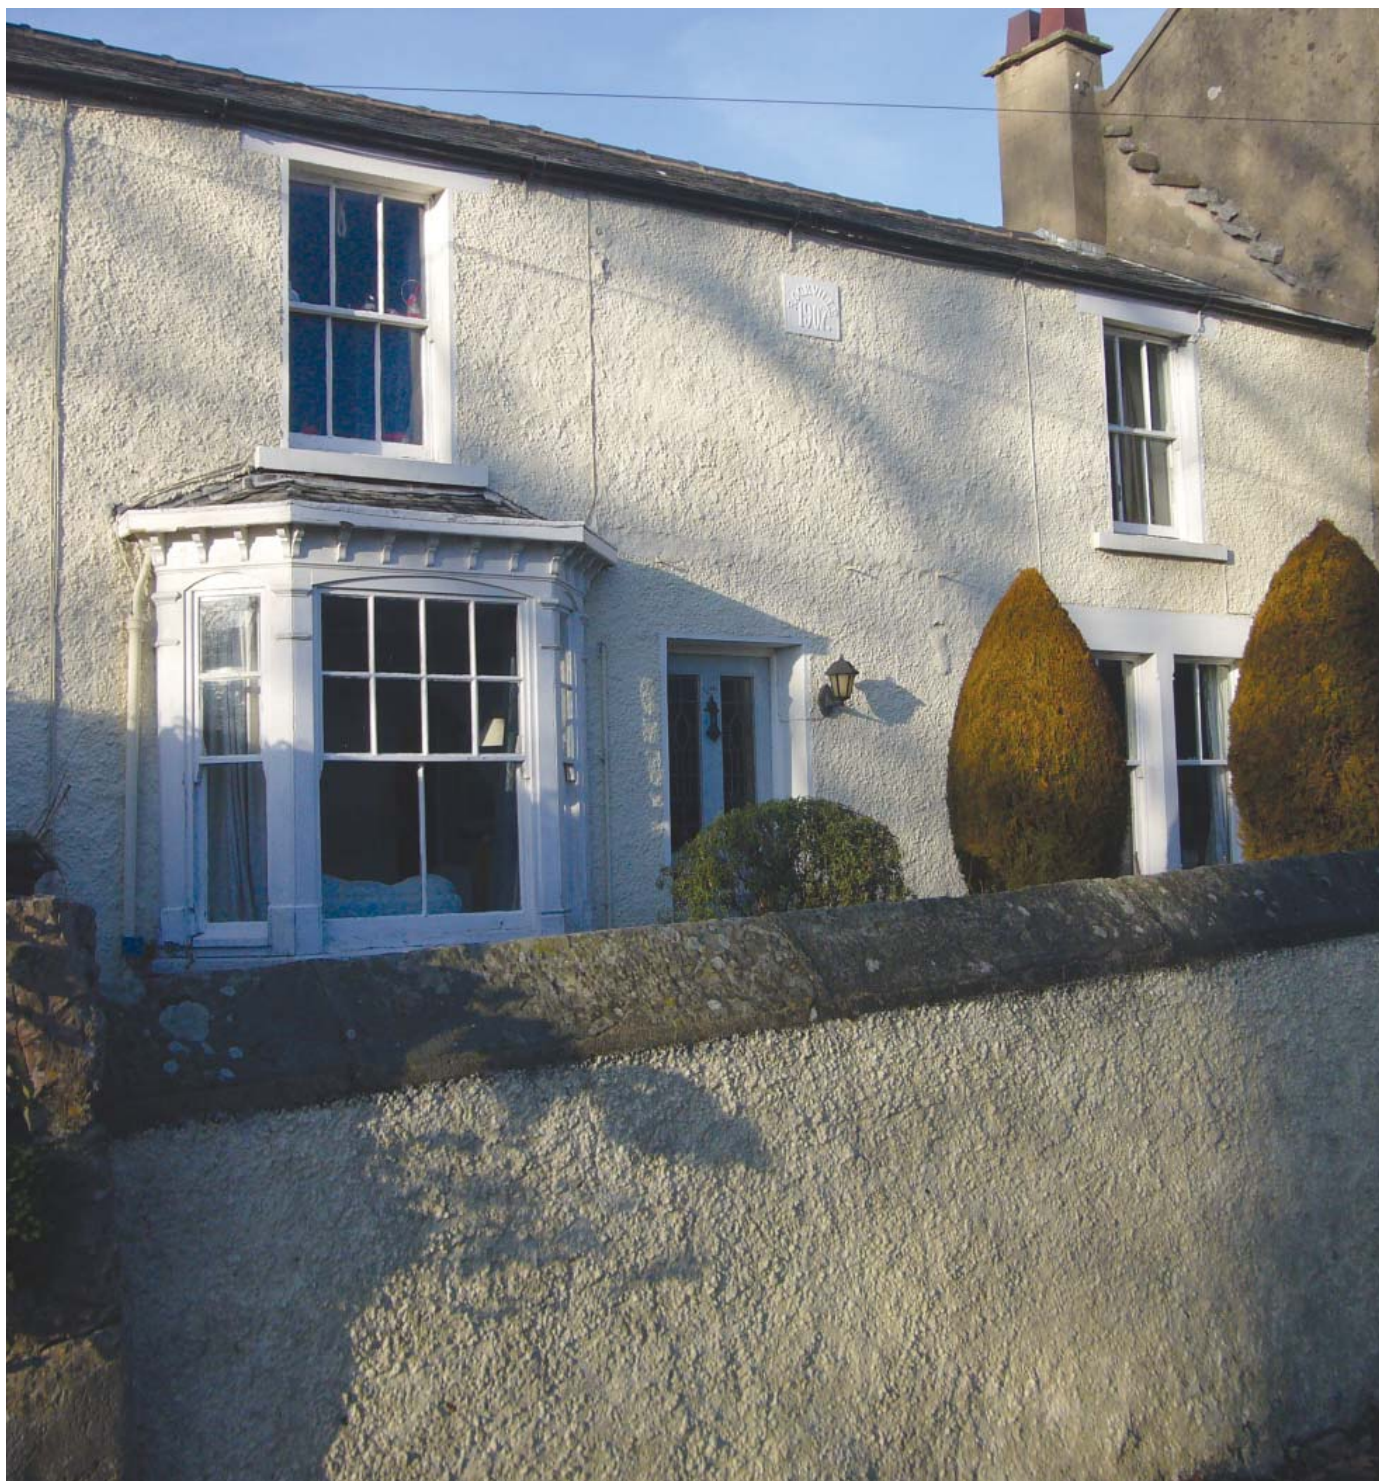
A well detailed Edwardian example of a canted bay window

- 5.3 Much of Warton's architecture is functional and unpretentious, of two bays, with simple rectangular openings for doors and windows, their front elevations undecorated apart from the occasional string course or datestone, and a shallow pitched slate-covered roof with gable-end chimneys. A few have projecting eaves brackets designed to support timber guttering.
- 5.4 With pretensions to slightly higher status are three-bay houses with a central door, some with prominent drip moulds over the windows and a canopy over the door, or houses with a single-storey canted bay window and a door case of moulded timber and door canopy.

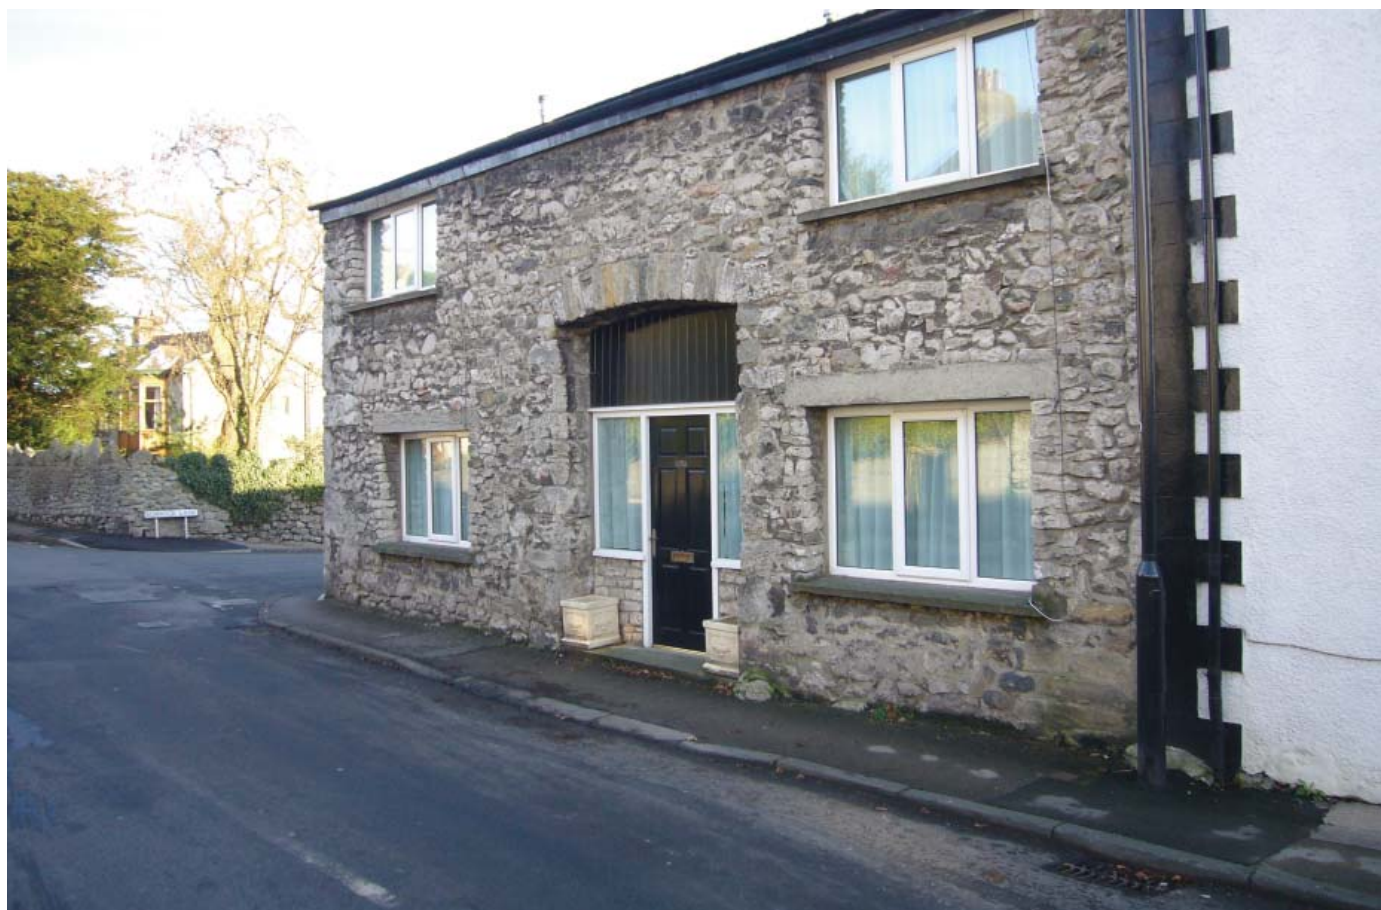
**The character of a barn can easily be lost through residential conversion**

- 6.5 There has already been a considerable amount of barn conversion in Warton and much of it that falls short of best practice in converting barns in such a way that they retain their essentially agricultural, rather than domestic character. Those barns that remain unconverted are all the more precious as a result, and any future development needs to be in keeping with the character of the conservation area and enhance that character rather than detracting from it.
- 6.6 Buildings that are potentially at risk from neglect, or from inappropriate 'restoration', include the listed barn attached to 115 Main Street, the listed buildings forming the farmyard around Boon Town Farmhouse, and the forge and barn on the corner of Crag Road and Holly Bank at the approach to the Crag Road car park.
