Arkholme

Conservation Area Appraisal

December 2015

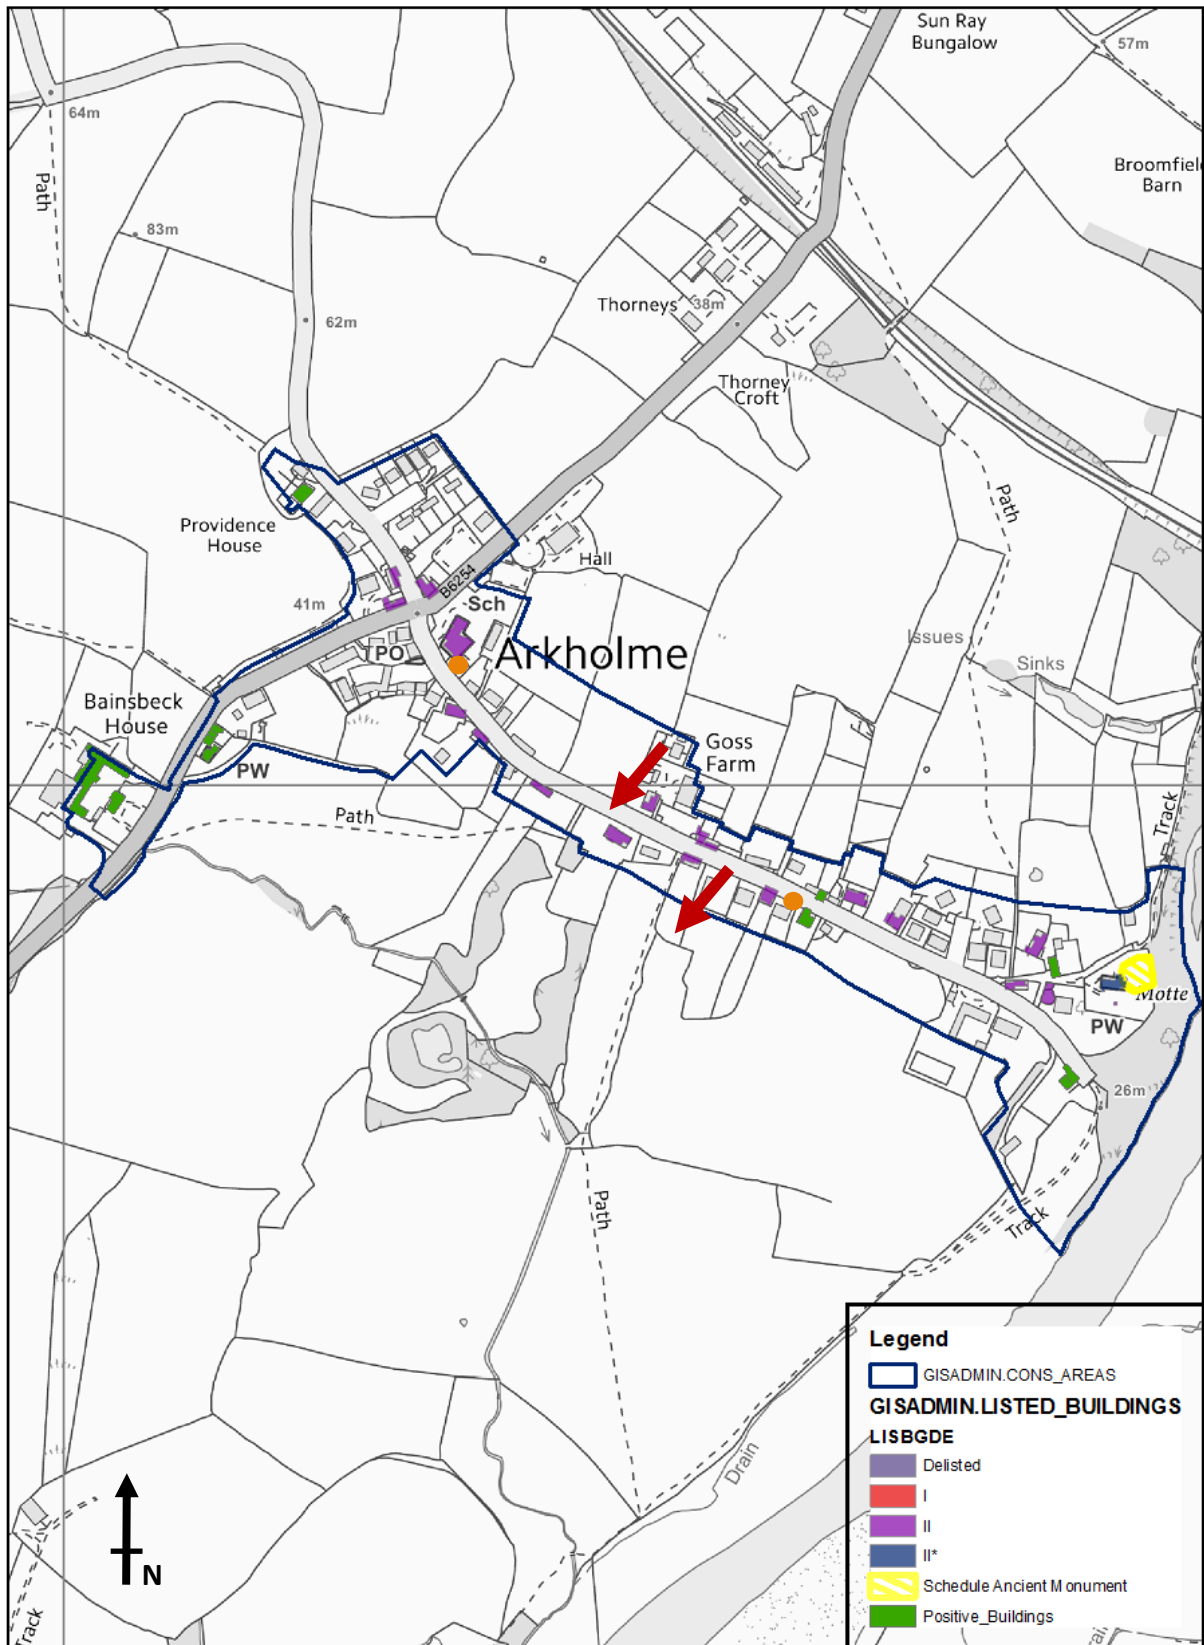
Fig. 8 Map of Arkholme's Conservation Area Boundary, the map also highlights listed buildings and positive contributions within the boundary. Important viewpoints, as discussed in section 4.1, have been highlighted with red arrows. Areas with Tree Preservation Orders are identified with an orange circle and discussed in section 4.5.

As seen in Fig. 8, the conservation area covers the whole of the village and some open spaces that contribute to the important rural setting.

Important vantage points include the incline near Goss Farm and along Main Street looking west. These have been identified on a townscape analysis map in Fig. 8.

There are five Tree Preservation Orders within the conservation area, which can be identified in Fig. 8. Mature trees contribute to the setting of the conservation area and anyone proposing to cut down or carry out work to a tree within a Conservation Area is required to give the Local Planning Authority six weeks prior notice.

The following structures and buildings have been identified on Fig. 8 as significant unlisted buildings that make a positive contribution to the historic legibility of Arkholme's conservation area:

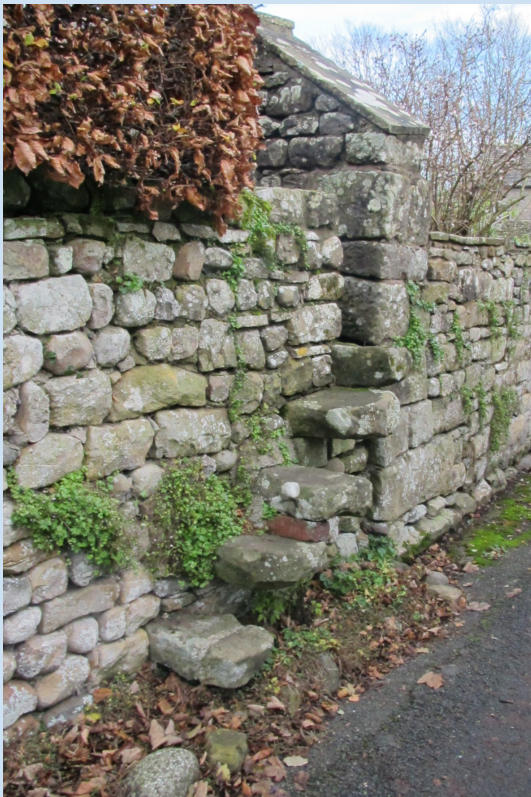
Fig. 12 Traditional drystone boundary walls characterise the village of Arkholme, some with flat coping stones.

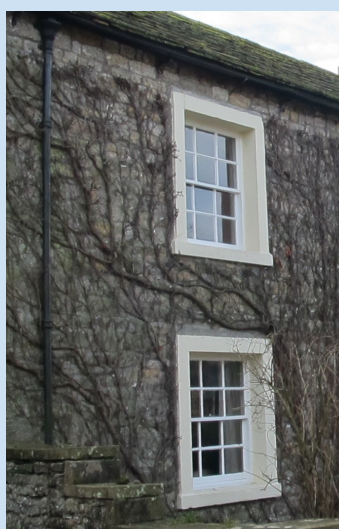
Fig. 30 Caulking House retains the traditional 6-over-6 sash window fenestration.

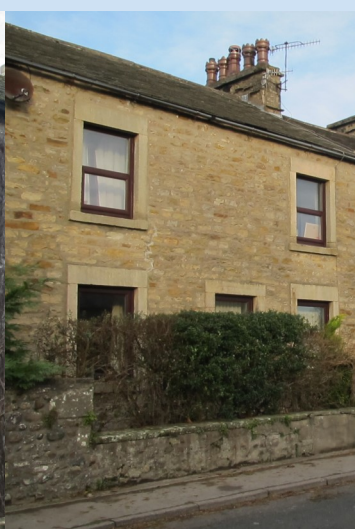
Fig. 31 Some traditional sliding sash windows have been replaced with unsympathetic modern mock-sash casement opening windows.
