WARTON

CONSERVATION AREA APPRAISAL

DECEMBER 2009

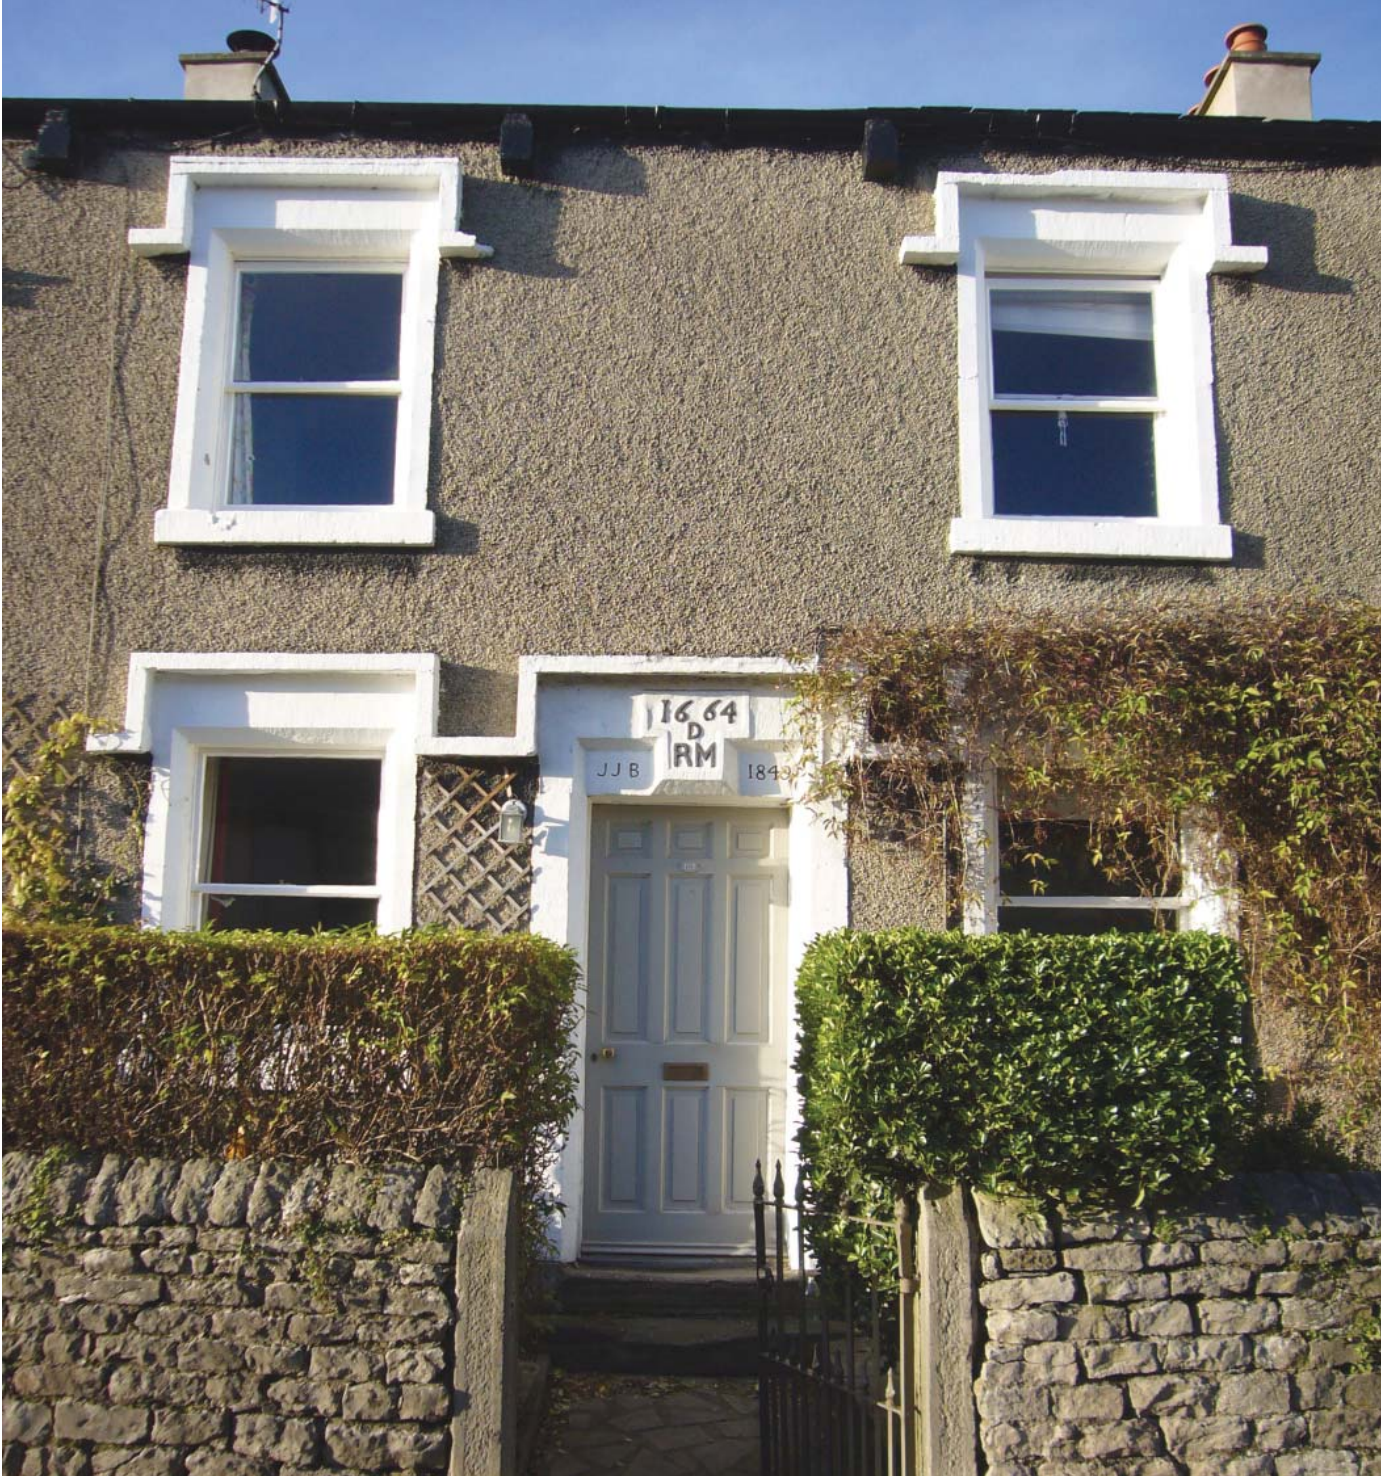
105 Main Street: a listed building dating from the mid 17th century

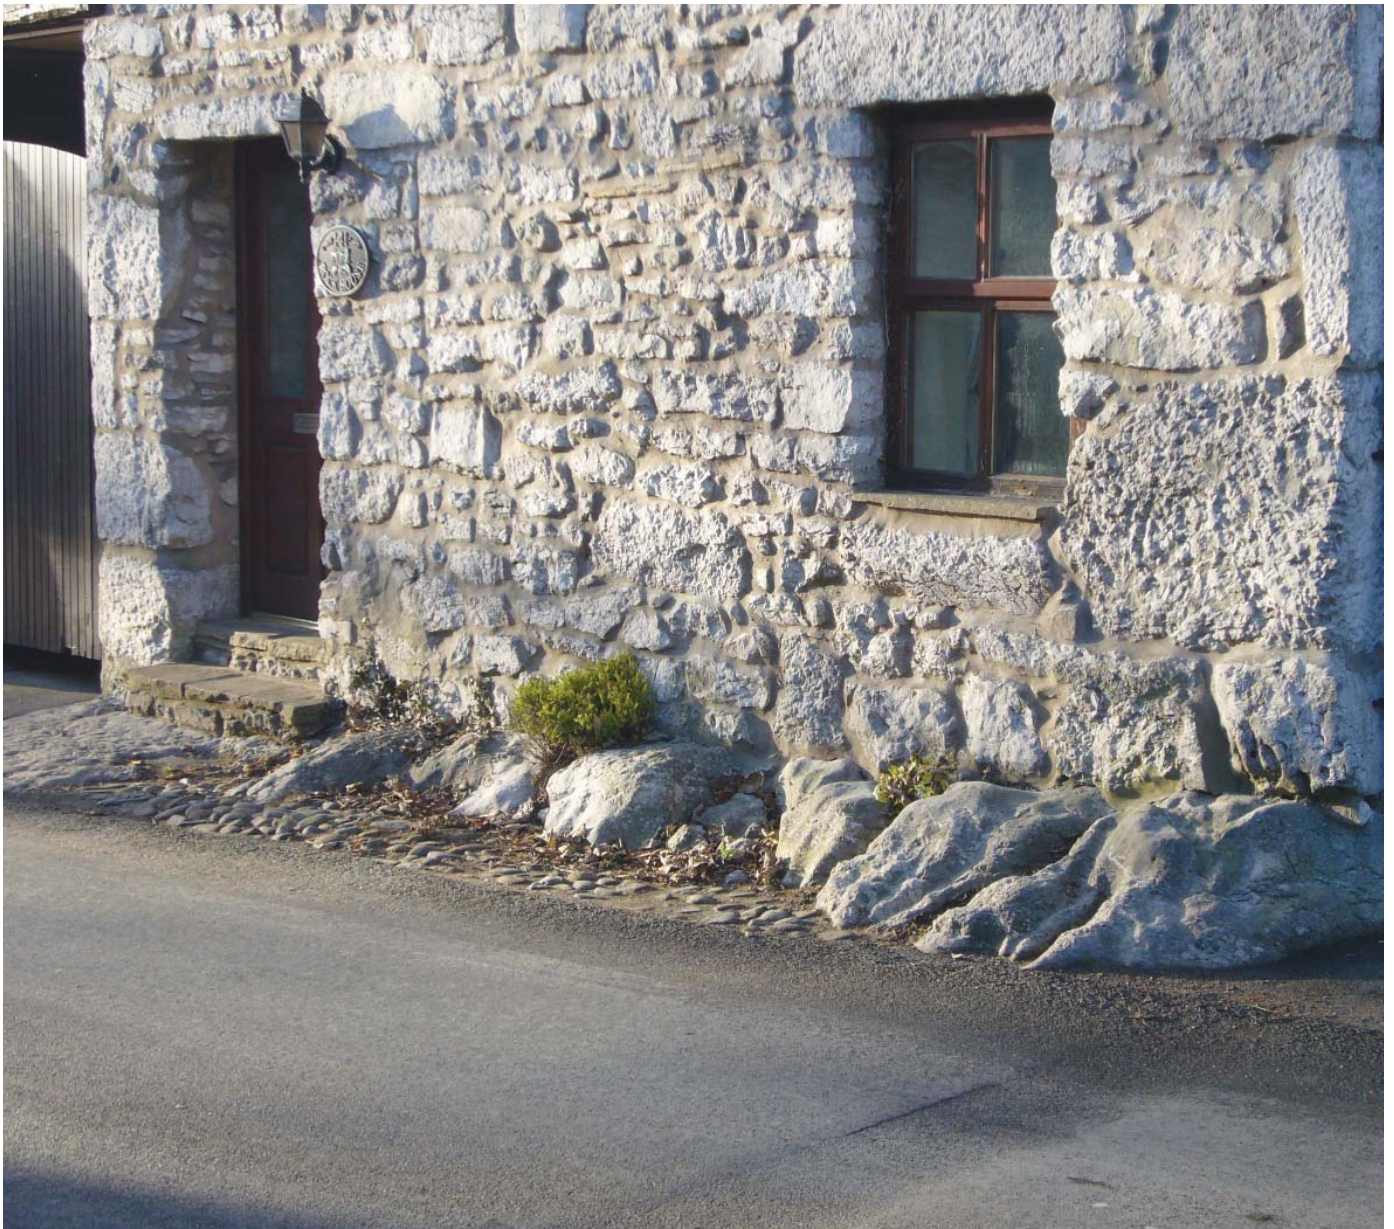
Former barn with bedrock foundations

- 5.1 The buildings of Warton are mainly constructed from the local carboniferous limestone, quarried from Warton Crag. Other forms of building stone are abundant in the locality and sawn sandstone is used for window and door surrounds. Often the main walling is made smooth by a thick coat of lime render. Some of Warton's buildings have since been stripped of render to reveal the rubble construction, with door and window surrounds that project further out from the wall than was the original builder's intention.
- 5.2 By contrast, functional agricultural buildings, which simply have gaps for windows, are appropriately left unrendered, and in once case the barn seems literally to grow out of the bedrock as its foundations are of massive in situ limestone blocks.

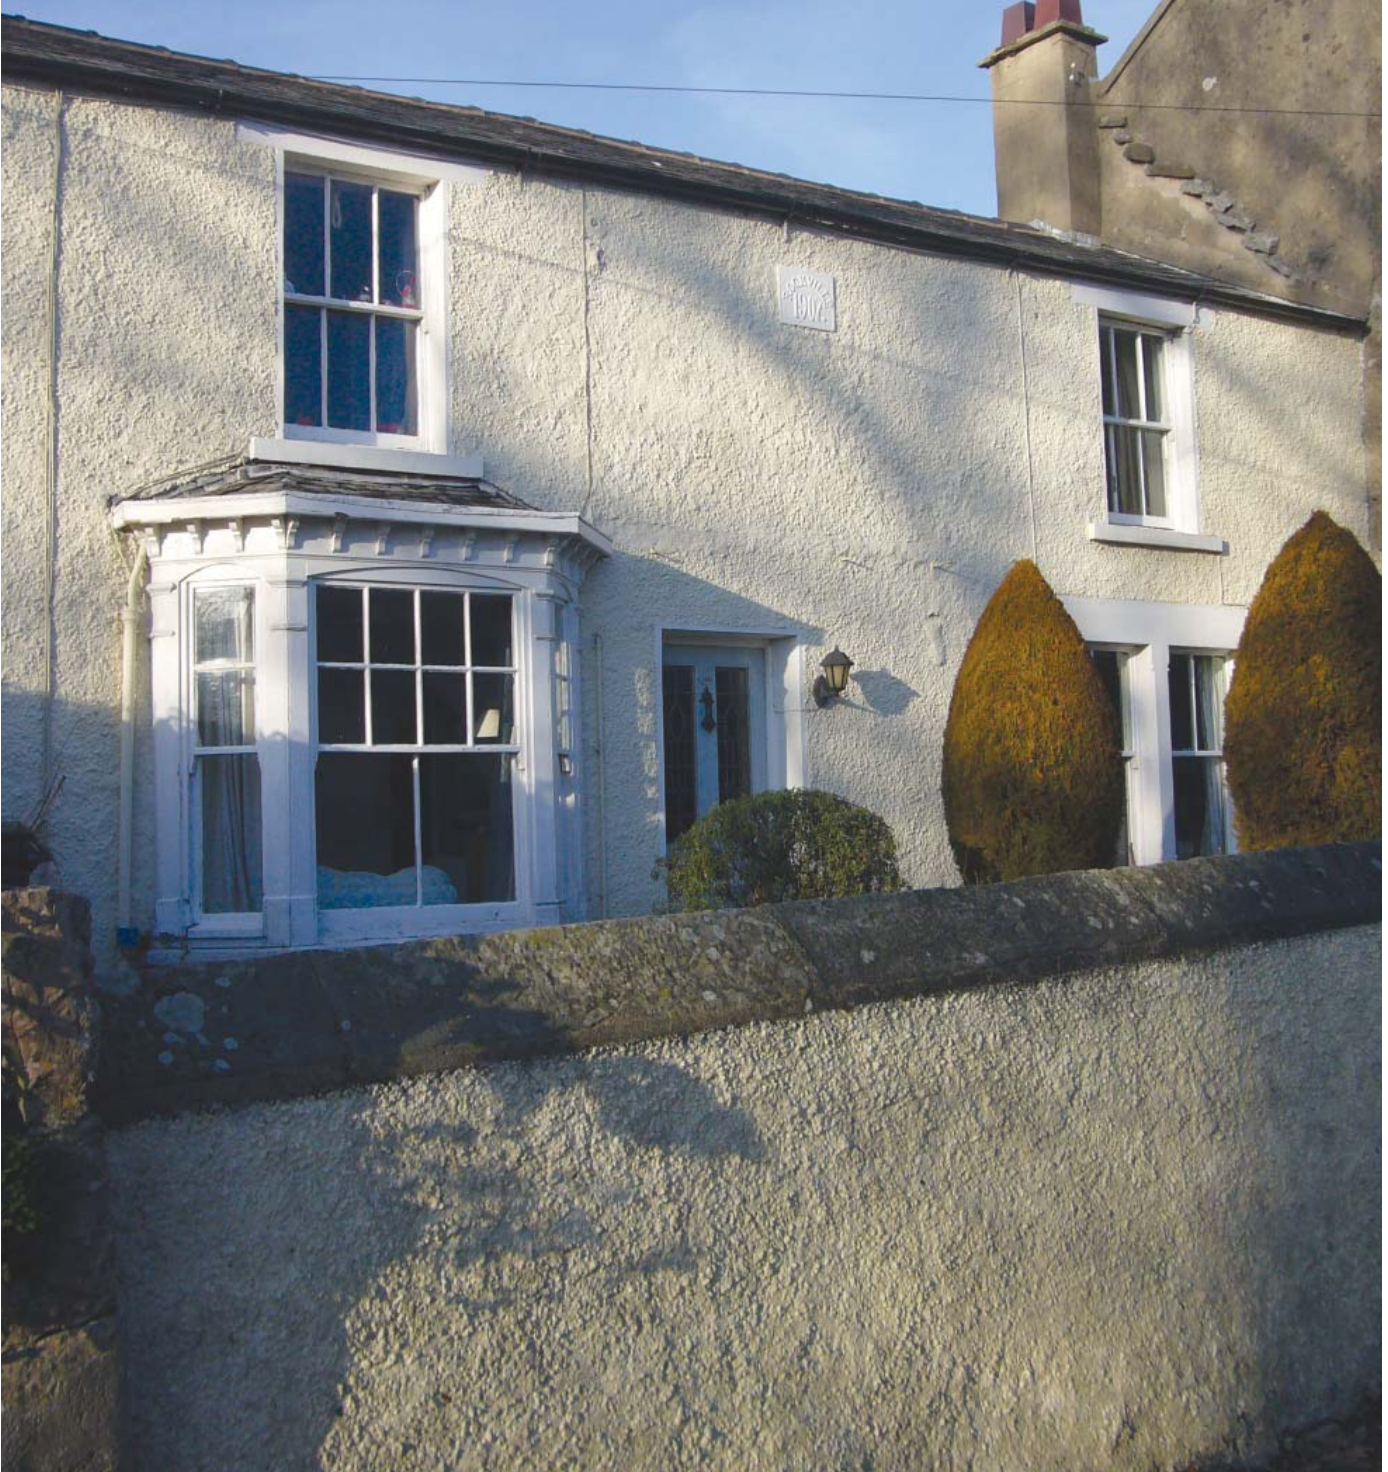
A well detailed Edwardian example of a canted bay window

- 5.3 Much of Warton's architecture is functional and unpretentious, of two bays, with simple rectangular openings for doors and windows, their front elevations undecorated apart from the occasional string course or datestone, and a shallow pitched slate-covered roof with gable-end chimneys. A few have projecting eaves brackets designed to support timber guttering.
- 5.4 With pretensions to slightly higher status are three-bay houses with a central door, some with prominent drip moulds over the windows and a canopy over the door, or houses with a single-storey canted bay window and a door case of moulded timber and door canopy.
