Glasson Dock

# Conservation Area Appraisal

April 2017

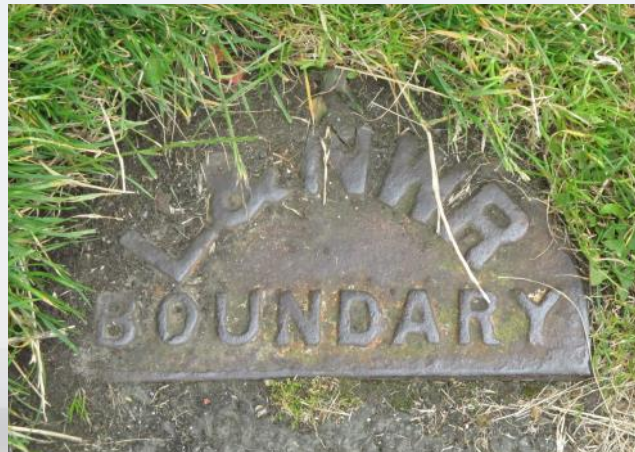
**Fig. 7** London and North Western Railway boundary marker. L&NWR owned the Lancaster Canal and the dock was owned by Lancaster Port Commissioners, this marked the end of L&NWR's ownership.

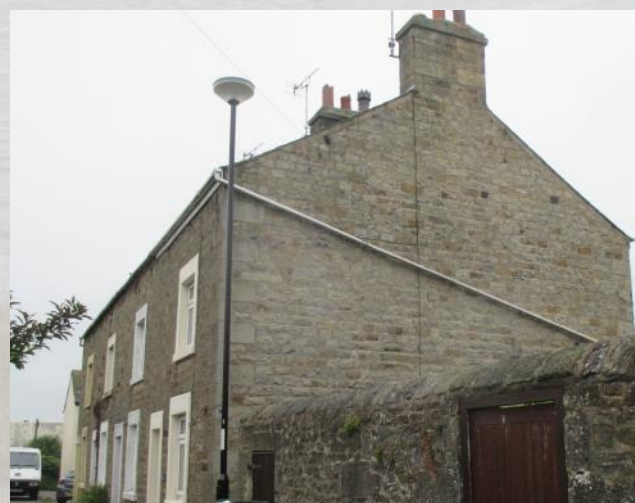
**Fig. 8** West View terrace are late-18th century stone-built houses for shipyard and port workers.

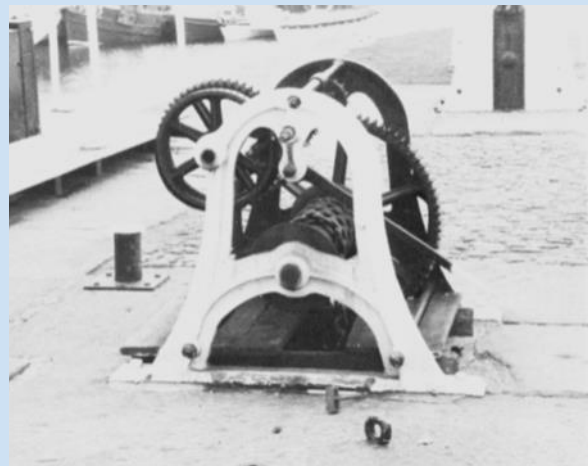
**Fig. 11** Lock gear at Glasson Dock, made at Phoenix Foundry (Price 1983: 52)

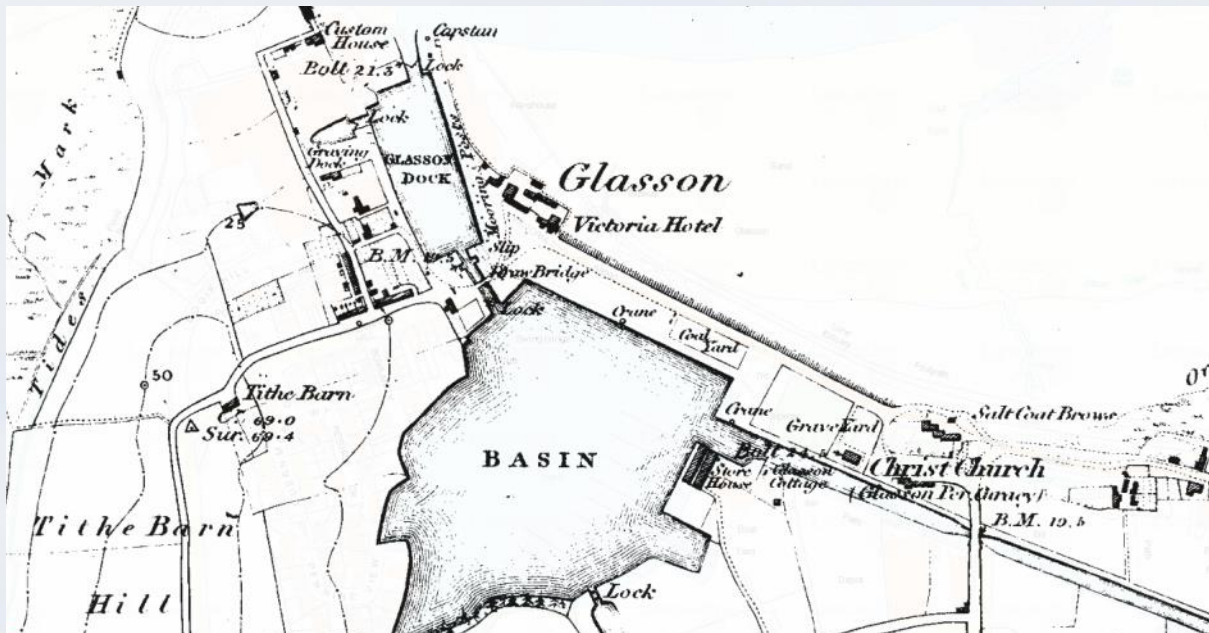
Fig. 12 1840s OS map of Glasson Dock

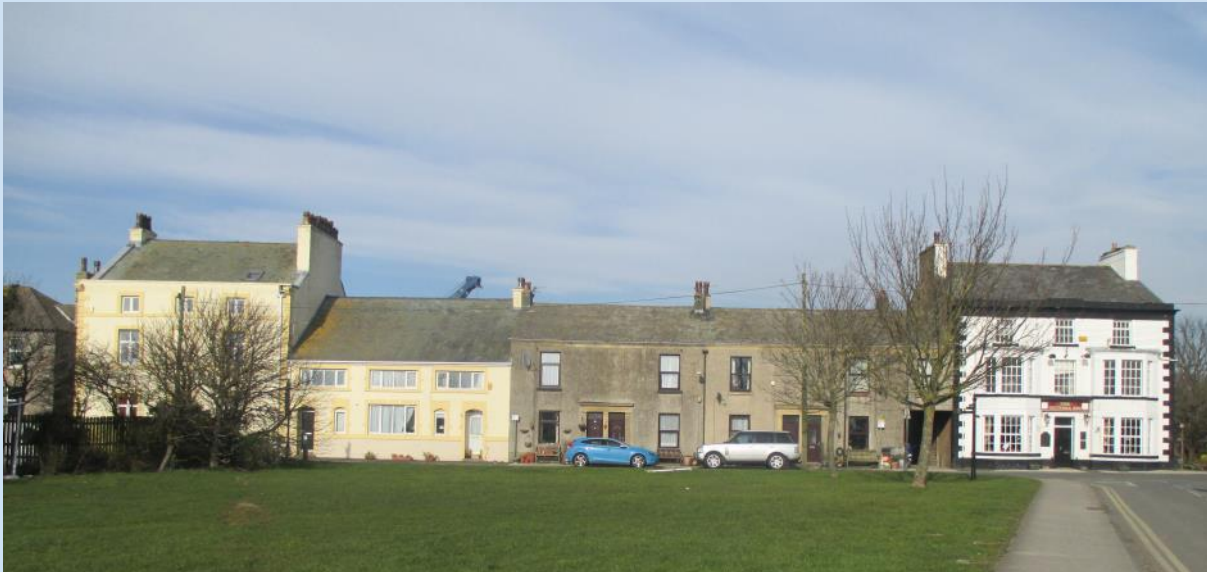
**Fig. 14** Victoria Terrace was constructed in late-18th to mid-19th century. The Caribou, on the left of the terrace, was formerly a pub and potentially one of the oldest buildings in Glasson Dock.

Many buildings in the area date from the late-18th to 19th century, with a mixture of styles and detailing. Along Victoria Terrace, there is a degree of formality in the styles of the buildings. The Caribou and Victoria Hotel have formal arrangement of proportioned stone surrounds of windows. Victoria Hotel has a double height canted bay windows added in the 19th century.

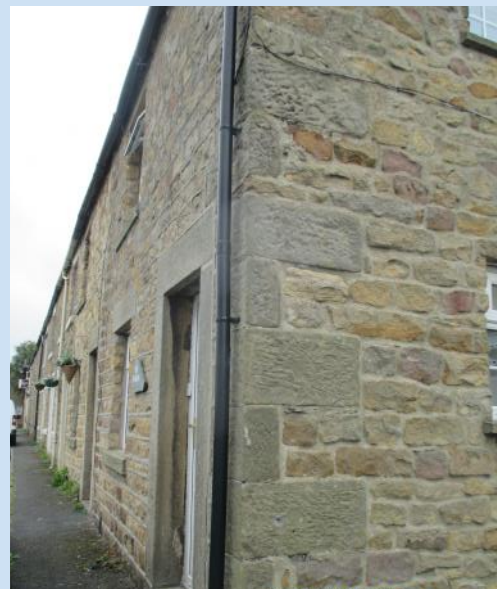
**Fig. 15** View along Tithebarn Hill - buildings face immediately onto the highway.

Near the dock, there is a relatively finer grain and linear pattern to the streets. Predominantly, houses and public houses face immediately onto the highway with some buildings enclosed by a low stone boundary wall. Some historic warehouses remain which have elongated plan form and run perpendicular to the dock, whereas modern 20th century warehouses have a large mass and footprint and dominate the surrounding land of the dock. Buildings become much more scattered next to the canal and Brows Bridge.

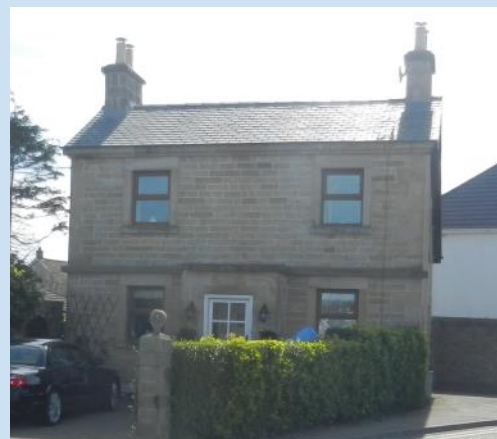
**Fig. 16** Lock Keeper's Cottage - a detached early-19th century house.

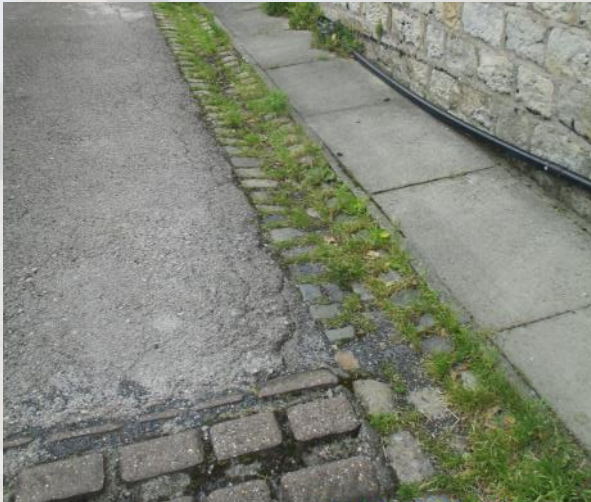
In general, the streets of Glasson Dock are of tarmac and are lined with pavements which are also of tarmac with a stone kerb. However, along West View there is still some cobbles retained along the street which gives an indication of the surfaces of the past.

**Fig. 17** Cobbles retained along West View add historic interest to the streets in Glasson Dock.

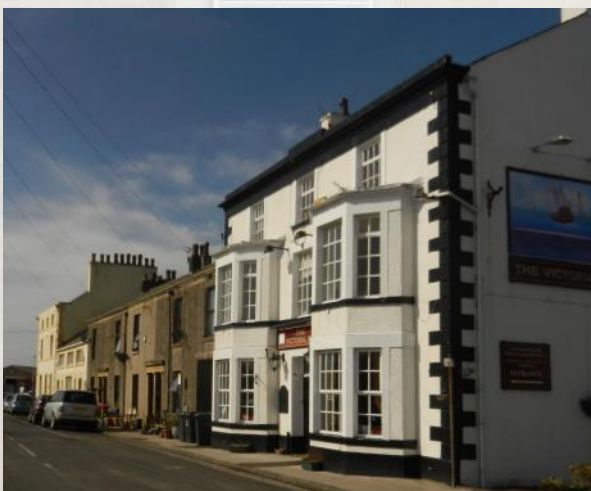
**Fig. 19** View of Victoria Hotel, a grade II listed public house, which dates from the 19th century which has a smooth render finish.

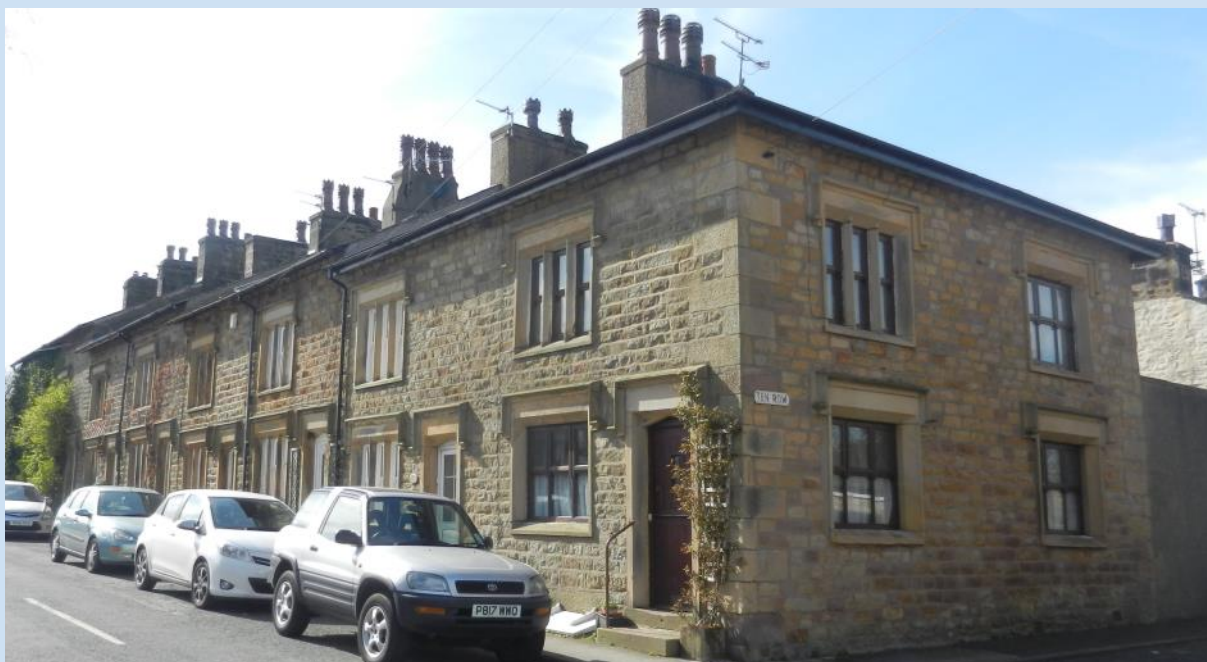
**Fig. 20** 20 - 34 Tithebarn Hill are terraced houses designed in mock-Tudor style. There has also been much unsympathetic alteration to windows and doors.

20 - 34 Tithebarn Hill have an unusual free 'Gothick' style with the stone mullioned windows with label-stop hood mould and a Tudor arch above the door. In comparison, those houses at 2-18 Tithebarn Hill, along West View, Ten Row and Railway Place have a more vernacular style influenced by the function rather than form. These either have simple stone surrounds or lintels to doors and windows. There has been some retention of original cast iron rainwater goods in some areas.

Historically, windows were timber sliding sash and doors were timber panelled doors. Although there has been Article 4 Directions in place since 1981 along Tithebarn Hill and Victoria Terrace, the area has seen a significant amount of unauthorised upvc replacement windows and doors and satellite dishes installed along the front elevation. These have severely detracted from architectural significance, thus undermined the historic interest in many of the buildings.

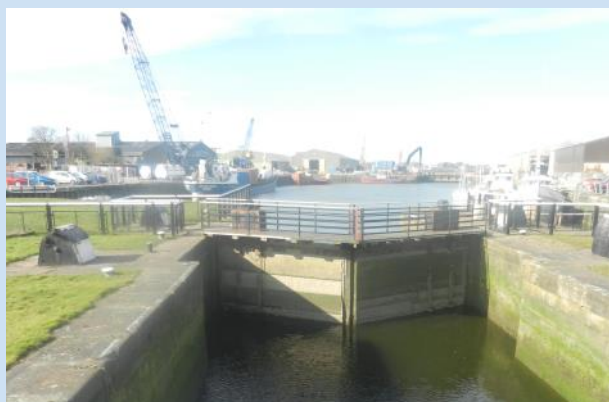
In the latter half of the 20th century, there has also been some unsympathetic development concentrated around the dock area including some large corrugated metal warehouses and some flat roof cafes south west of the dock. In addition, there has been significant amount of detached modern houses constructed to the west of the dock, most of which are excluded from the boundary. Overall, there still remains an overriding historic impression through retention of buildings, but modern developments and alterations to detailing have undermined this significance.

**Fig. 21** Modern development adjacent to the dock dominates the historic significance of the site.

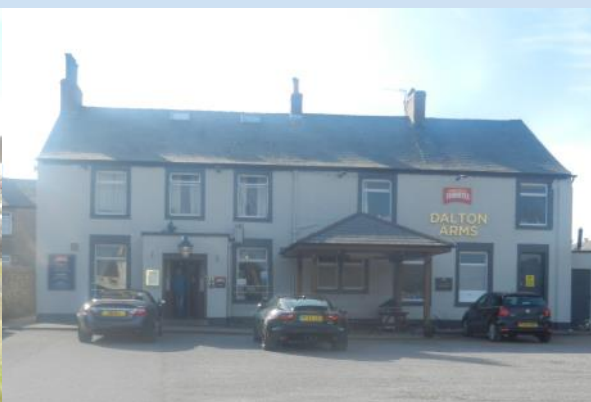
**Fig. 22** The Dalton Arms, is a converted terrace of houses into a public house.

Terraced houses, such as Tithebarn Hill and Ten Row, date from the late-18th to early-19th century and were built to accommodate the growth in dock workers. This part of the settlement also includes a Lock Keeper's Cottage and the Dalton Arms, a late-18th century terrace converted to a public house. Many houses and public houses, such as those along Victoria Terrace, date from the early to mid-19th century. The Caribou, originally known as Pier Hall, is speculated to be one of the oldest buildings in Glasson Dock as it got its first licence in 1781.

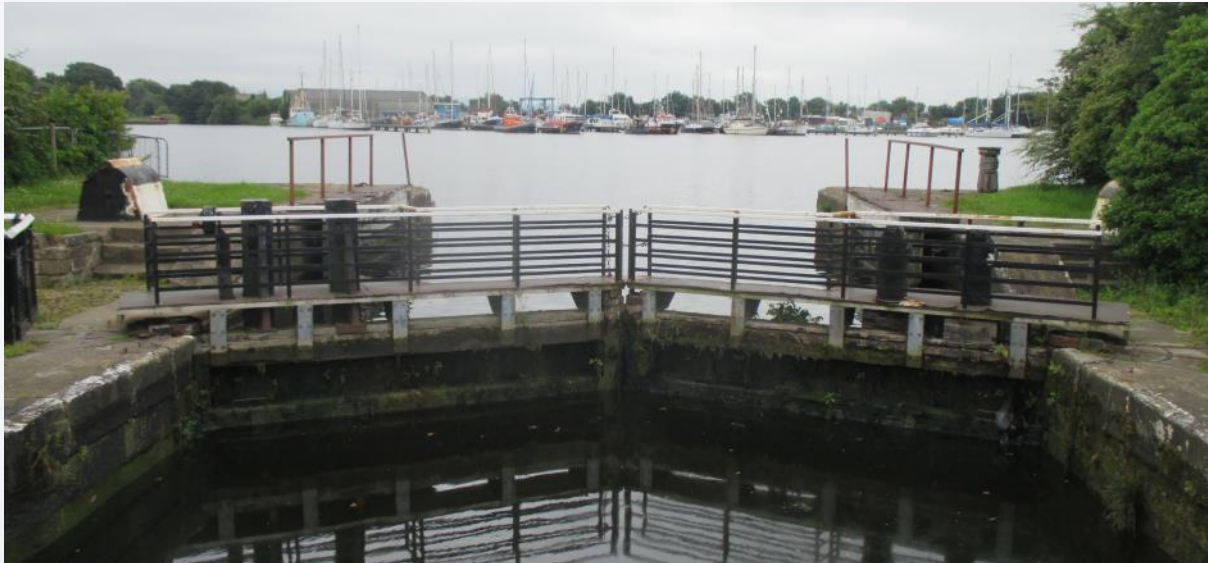
**Fig. 23** Lock of Glasson Dock which leads to the canal basin. The locks have solid masonry walls with a modern swing bridge across.

Within the conservation area, there is a scheduled monument which is protected under the Ancient Monuments and Archaeological Areas Act 1979. The scheduling covers a rare surviving example of a late-18th and 19th century commercial dockyard. As seen in Fig. 5, the scheduled area includes the wet dock which was constructed in 1800, the East pier, pier head, graving dock and lock entrance to the canal basin.

The area largely remains in use for trade, but as a result has become dominated by modern late-20th century warehouses. In addition, the graving dock has been infilled to be a car parking area, which erodes its significance. Nonetheless, the site provides evidence of the historic development of the area and is a potential resource for future archaeological research or interpretation.

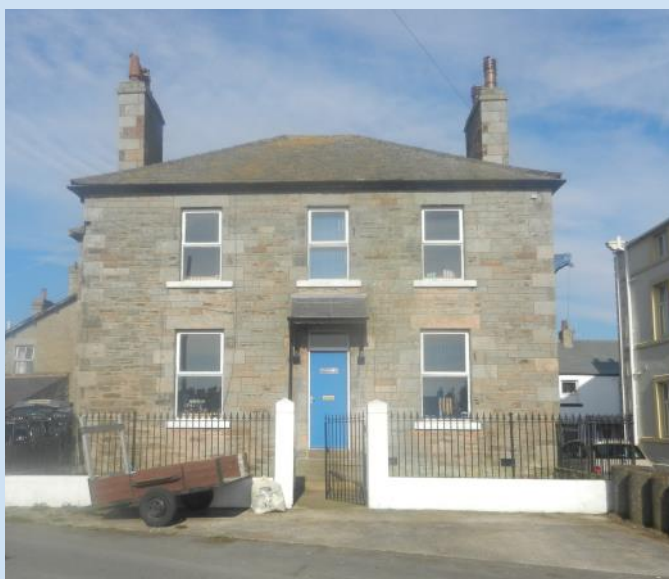
Fig. 25 Harbour House along Victoria Terrace dates from 1800.

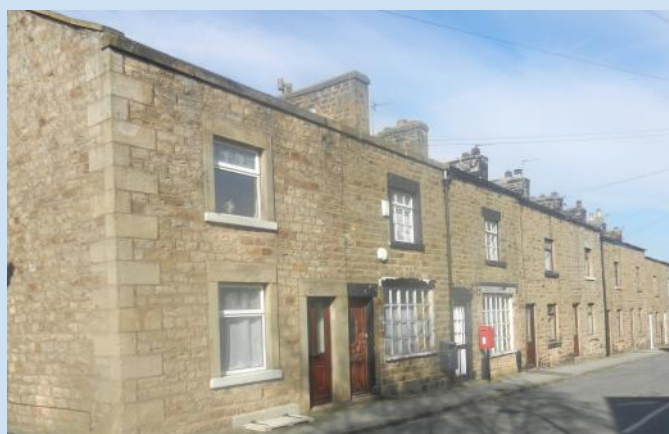
Fig. 26 2 - 18 Tithebarn Hill was constructed in the late-18th century. Some of the houses had shopfronts and used a post office, but returned to a house.

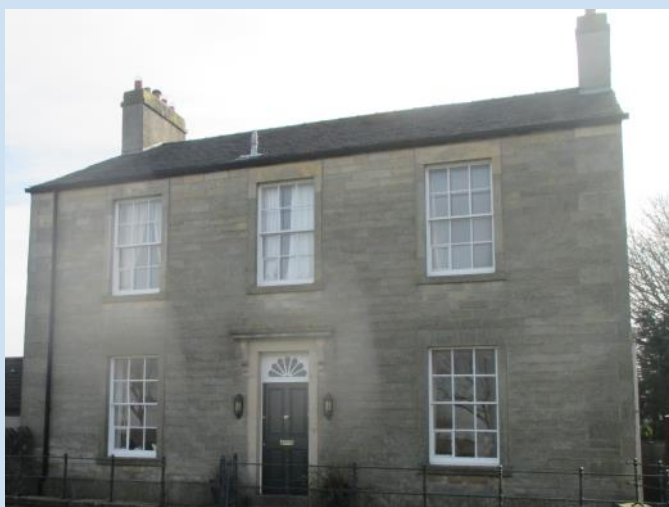
Fig. 27 The Vicarage is a late-19th century house in connection to St John's Church, has retained its 6-over-6 sash windows and timber panelled door with fanlight.

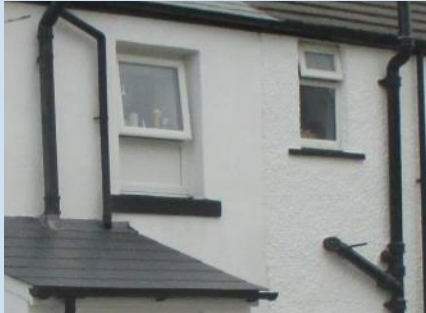
**Fig. 29** Inappropriate top hung uPVC windows have a negative impact on the area.

In some buildings, traditional windows and doors have been replaced with uPVC alternatives or have inappropriate dark stained timber rather than traditional paint finish. In addition, the openings have been significantly altered with these modern alternatives. Traditionally, windows were sliding sash and often been replaced with top-hung casement openings. These non-traditional doors and windows negatively impact the character and appearance of the buildings, which subsequently has a detrimental impact on the special interest of the conservation area.

To prevent and mitigate further inappropriate alteration and development, a design guidance notice document could be provided to those properties subject to an Article 4 Direction. This could advise what would require planning permission and indicate what changes would be looked upon favourably. A consultation event could be held to promote awareness of conservation issues.

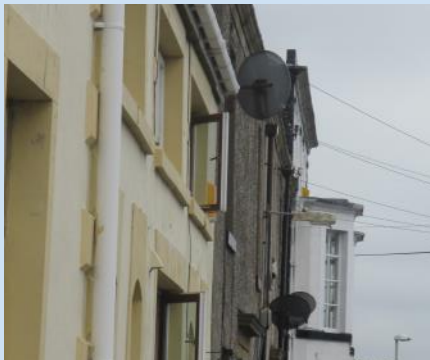
**Fig. 30** Satellite dishes along front elevation.

There are numerous instances of satellite dishes and alarm boxes situated in prominent position on a building, such as the front elevation. This severely impacts and undermines the historic character and architectural interest in the area. Many of these are unauthorised as they would normally require planning permission and this alteration would be strongly discouraged to be located in prominent position.
