## CONSERVATION AREAS

## 1.0 INTRODUCTION

- 1.4 The Halton Conservation Area was first designated in 1981 by Lancashire County Council under provisions that are now contained in Section 69 of the Planning (Listed Buildings and Conservation Areas) Act 1990. This defines a conservation area as 'an area of special architectural or historic interest, the character or appearance of which it is desirable to preserve or enhance'.

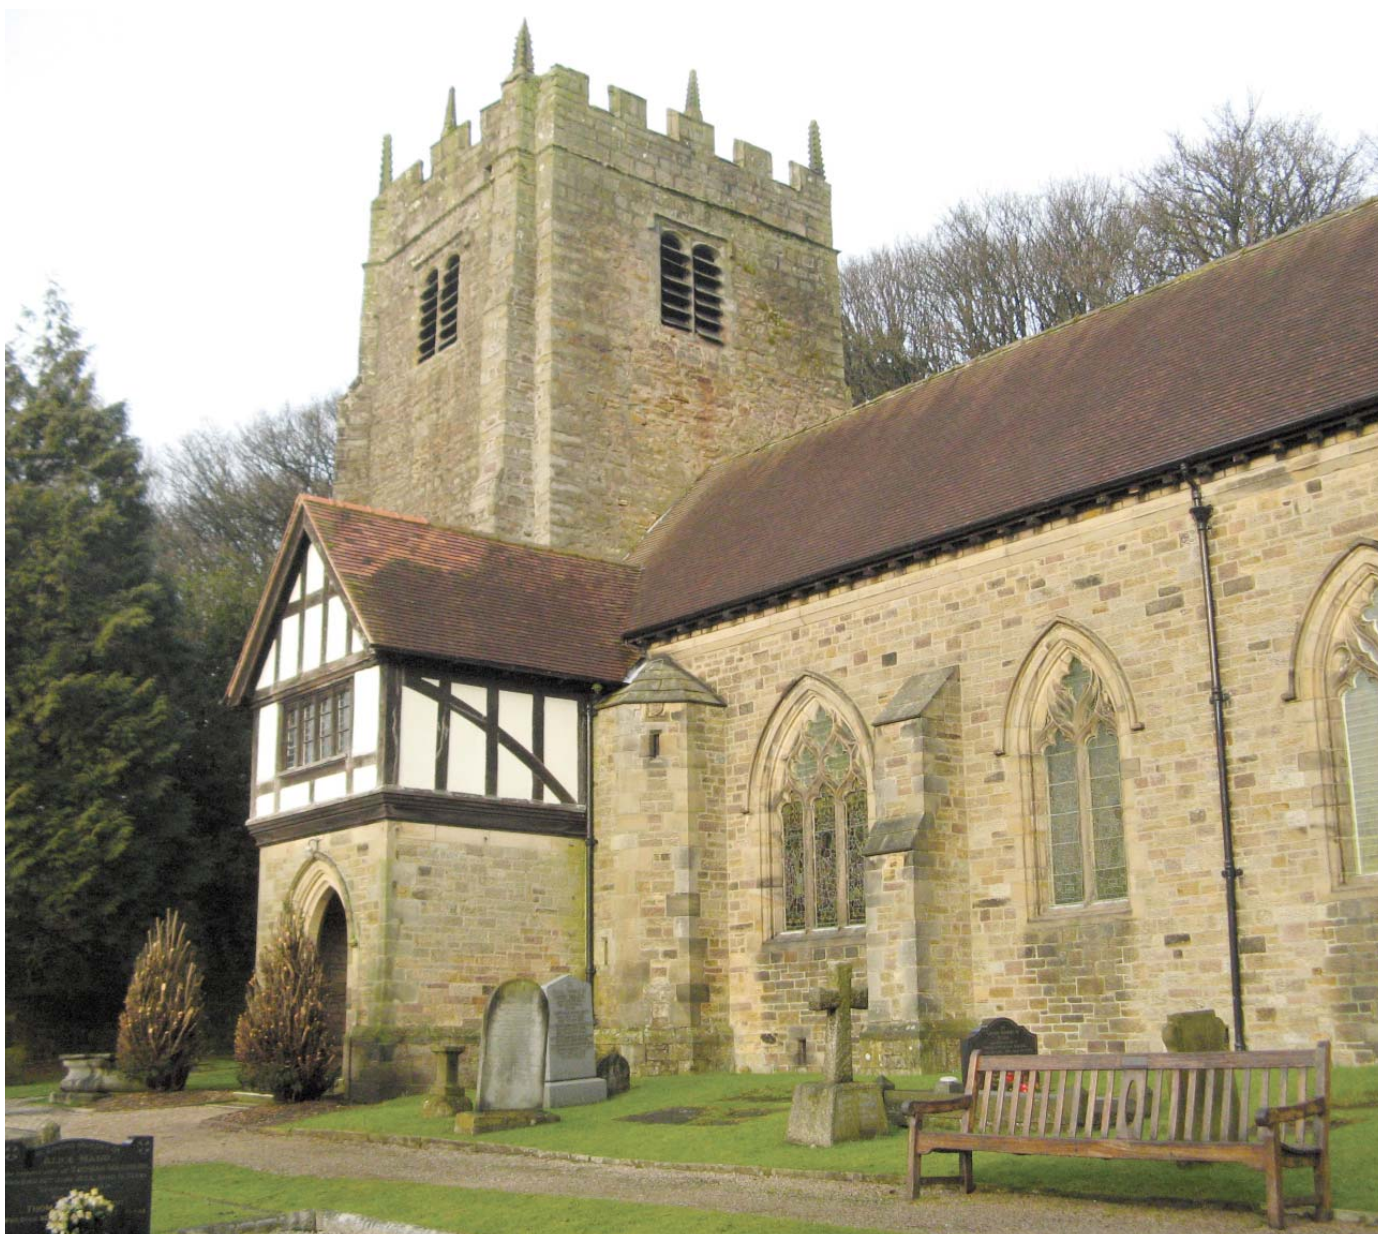
Church of St Wilfrid

- 3.4 St Wilfrid's Church is said to pre-date the Conquest, although the earliest records date from 1190. It was extensively repaired in the 14th century, rebuilt in 1792 and again in 1876 to designs by the Lancaster architects Paley and Austin. Of the earlier work, only the tower survives, perhaps from the 16th century.

- 5.2 Early roofs were probably of stone slabs, but these are less common now since the railway age brought plentiful slate from Wales. St Wilfrid's Church has a clay-tiled roof, which is characteristic of the work of Paley and Austin.

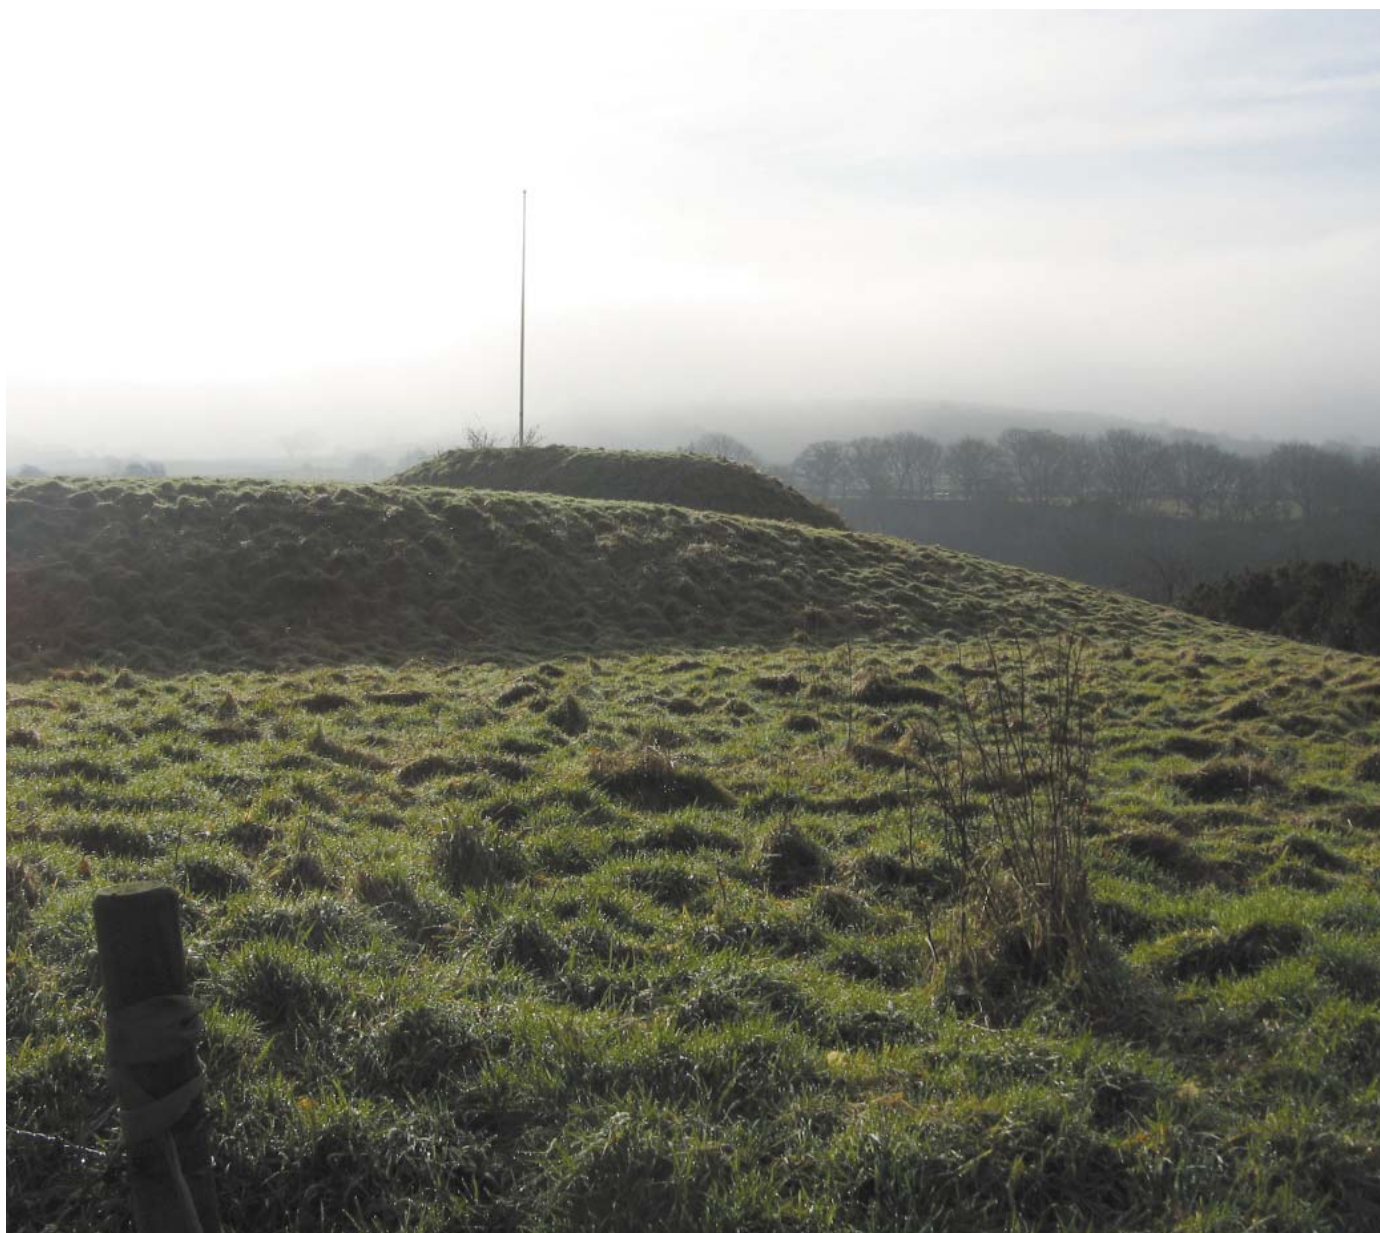
Earthworks of the 11th century castle

- 3.2 The evidence of this importance survives in the earthworks of the 11th century castle, which retains its motte and bailey form at the centre of the village. There is also a Saxon cross, dating from the 11th century, which stands in the churchyard where it was re-erected in 1891.

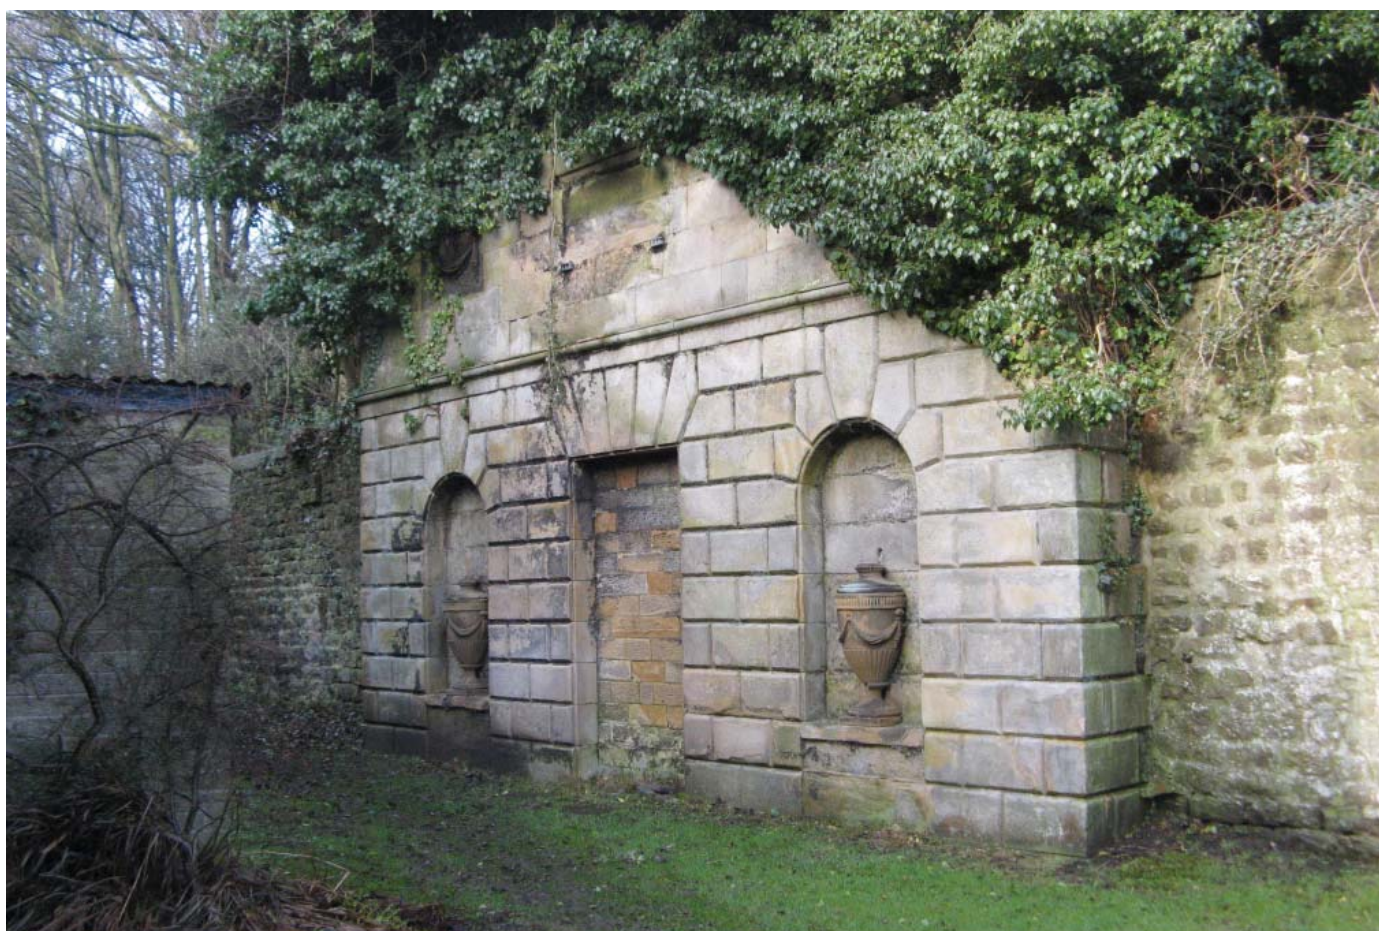
**Bradshaw mausoleum**

- 3.8 In 1748, the manor was acquired by William Bradshaw and it remained in the family for almost a century. The substantial Bradshaw mausoleum was built on the north side of the church in 1775, although the church was probably smaller then.

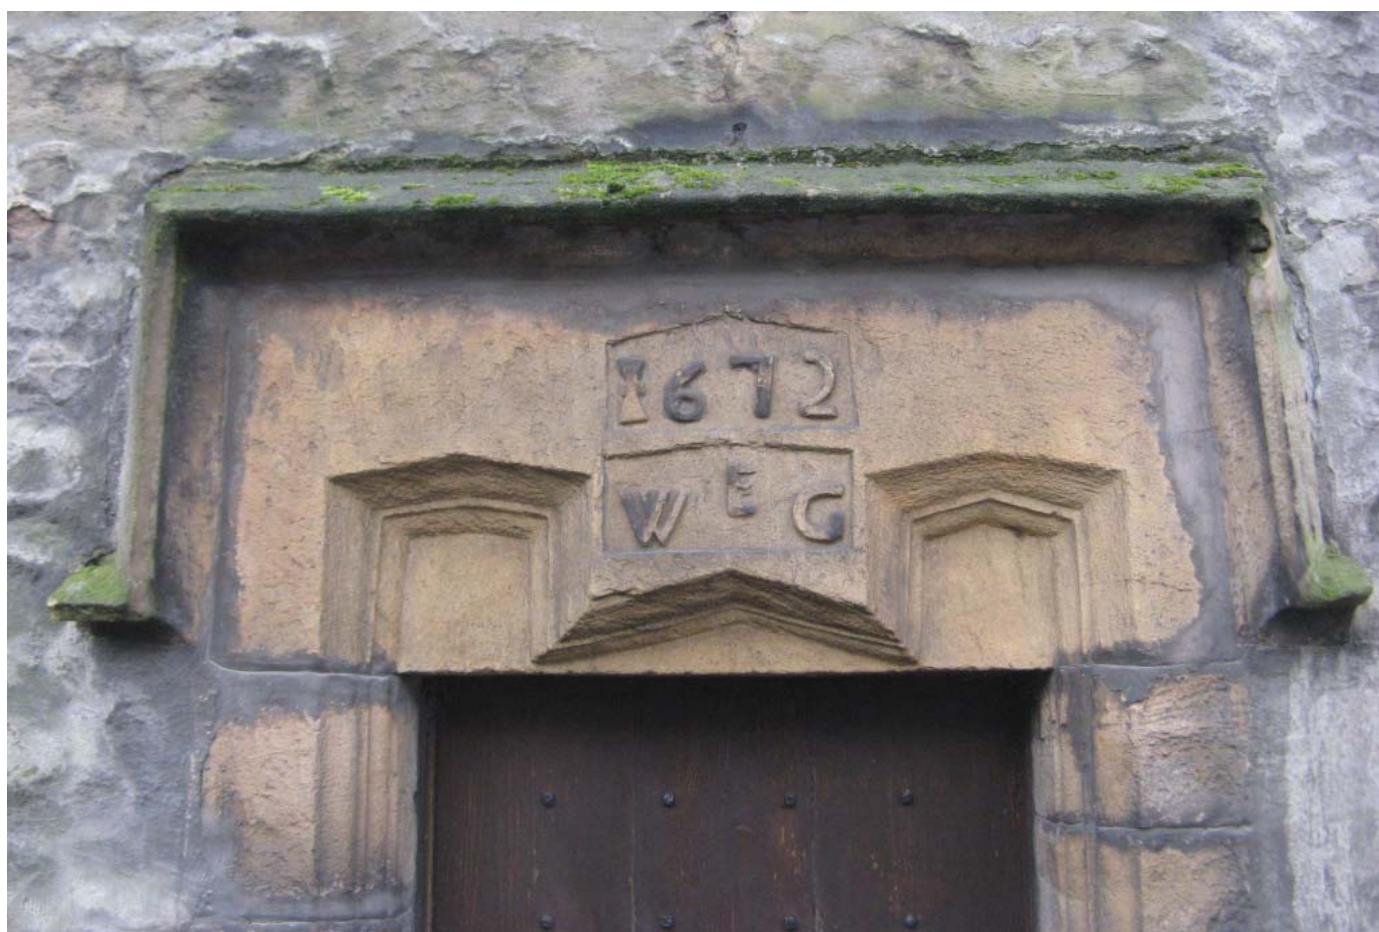
Ornate datestone

- 5.3 Buildings dating from the 17th and 18th centuries were built in the local vernacular tradition i.e. by local people using readily available materials and constructed with locally known practices of stone building and roofing. These buildings do not conform to a uniform architectural style, although features, such as mullioned windows with drip mouldings, gables with kneelers and copings, and ornate datestones, are common.

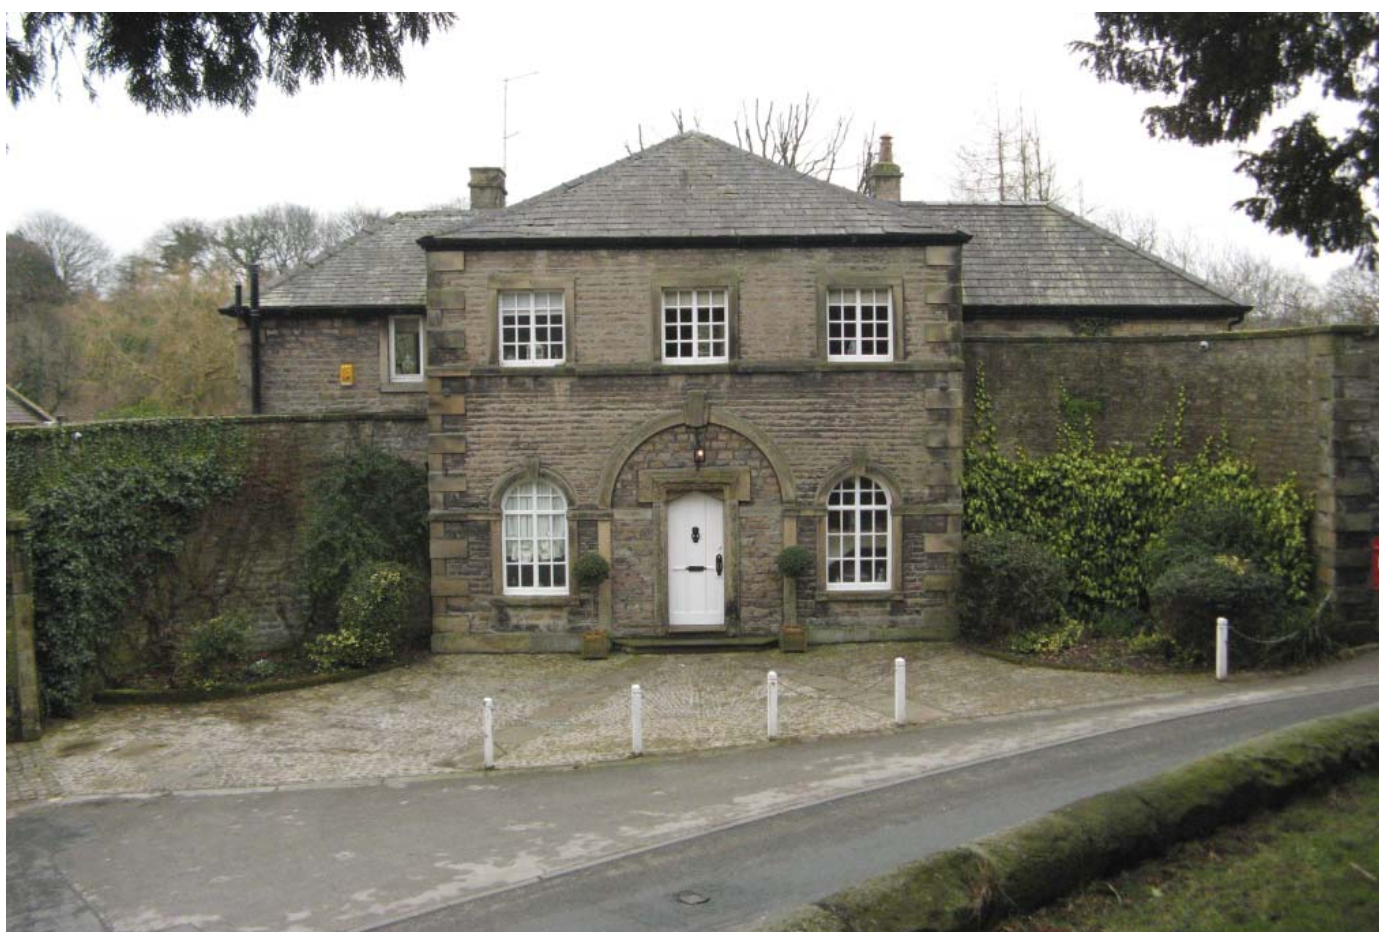
Clock House

- 5.4 From the mid-18th century onwards, a degree of formality and classical detailing enters the village. Typical of this are the Clock House, the gatepiers to the former Halton Hall and the Bradshaw Mausoleum. The stone tradition continued in the 19th century with houses that have symmetrical frontages with doors in the middle bay. These were the homes of the new businessmen. The Victorians also revived historical styles, for instance with the return to mullioned windows at St Wilfrid's Hall and, indeed, the 14th century styling of the rebuilt church.

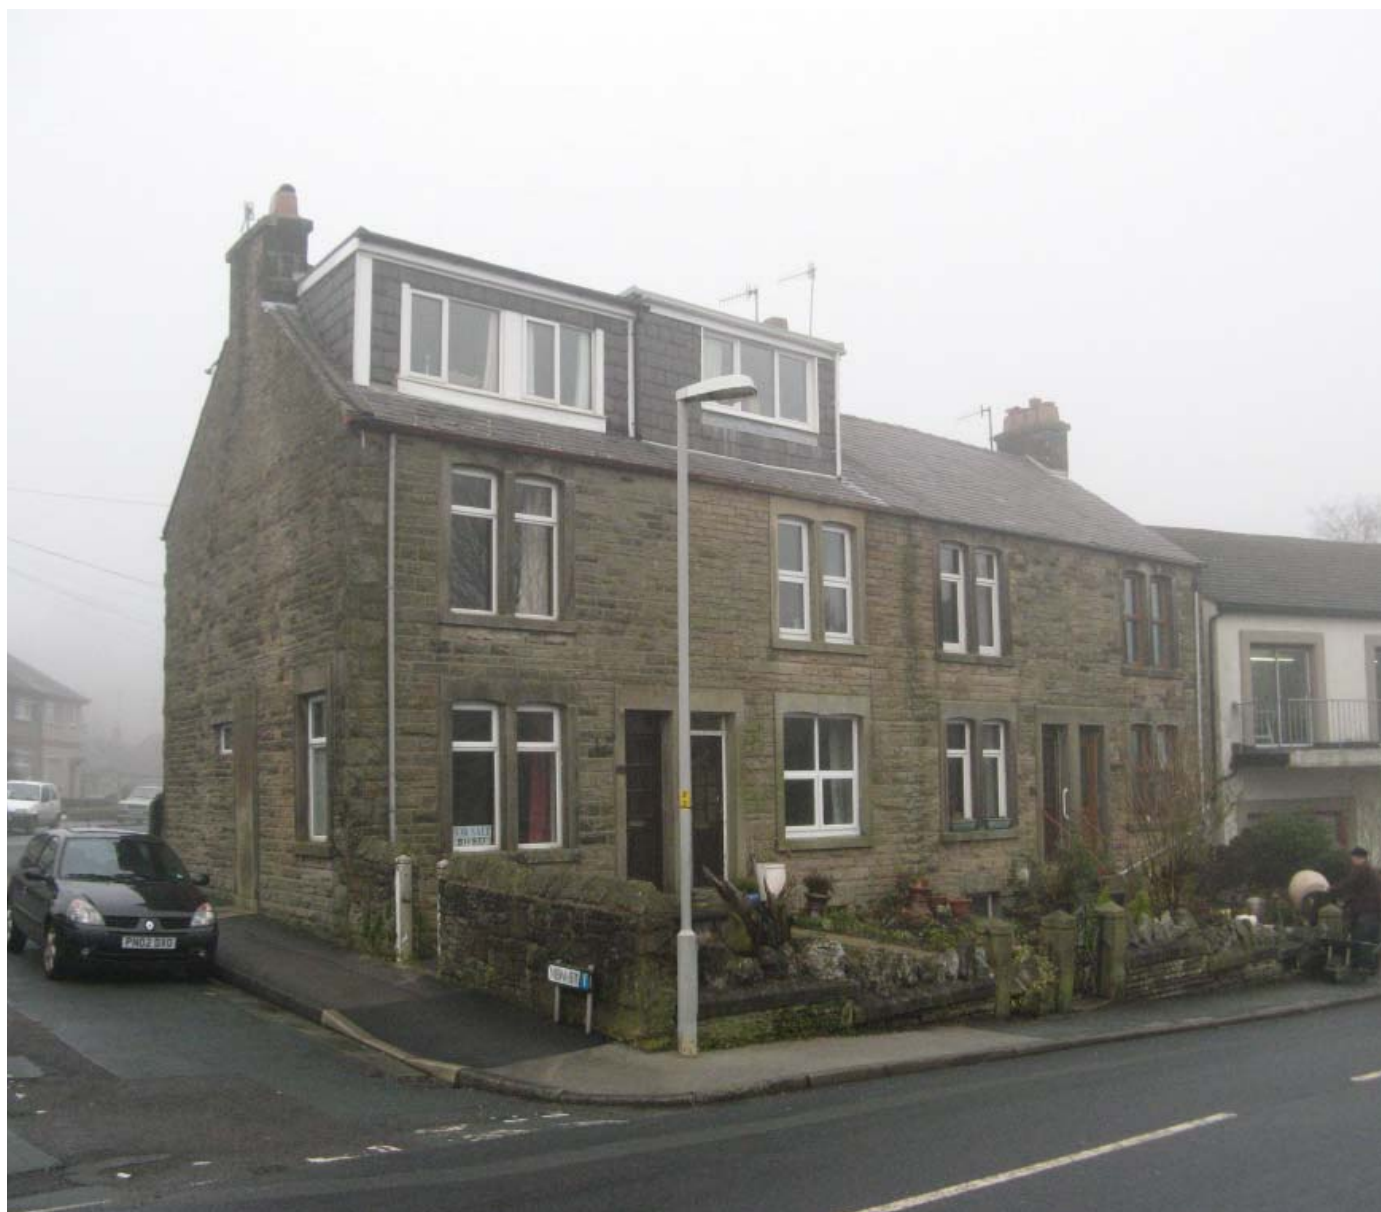
Modern alterations

- 6.2 In some cases, door and window openings have been altered, for example to create large wide windows in place of taller narrow ones. There are also instances where buildings have been extended in a manner which does not reflect the traditional design of the area's buildings, or that uses non-traditional construction materials. All of these have the effect of detracting from the original character of the host buildings.

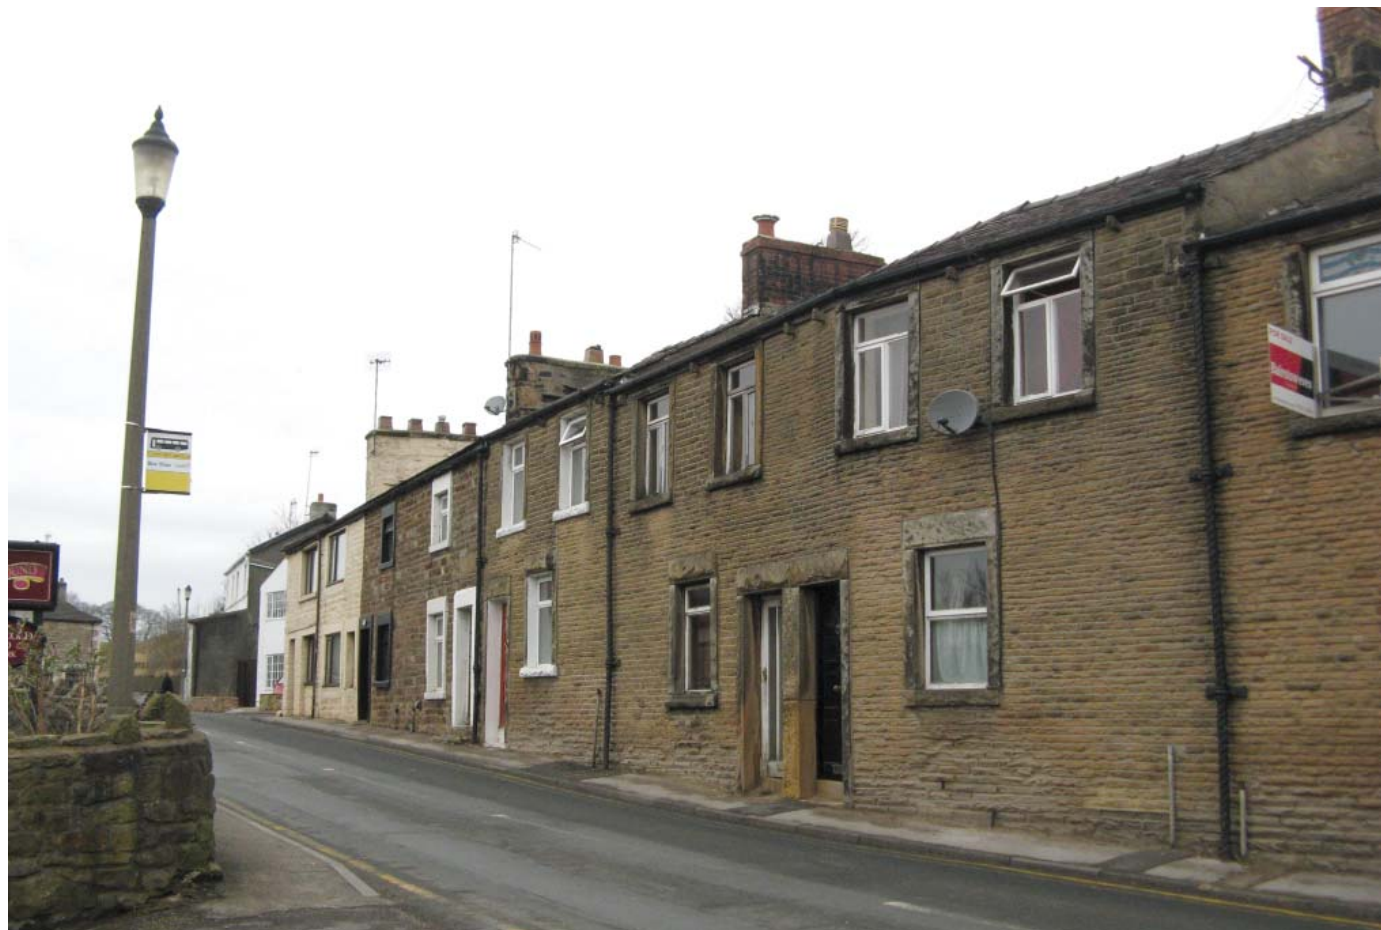
Satellite dishes

- 6.3 There are a number of instances where accretions such as satellite dishes and alarm boxes have been made on the elevations or chimney stacks of the historic buildings or where drainage pipes have been inserted in prominent positions, or rooflights inserted into the principal roofslope.
